# Water Distribution Seismic Performance 1994 Northridge-1995 Kobe Earthquakes

Le Val Lund, P. E., Craig Davis, P. E.,  
and Martin Adams, P. E.

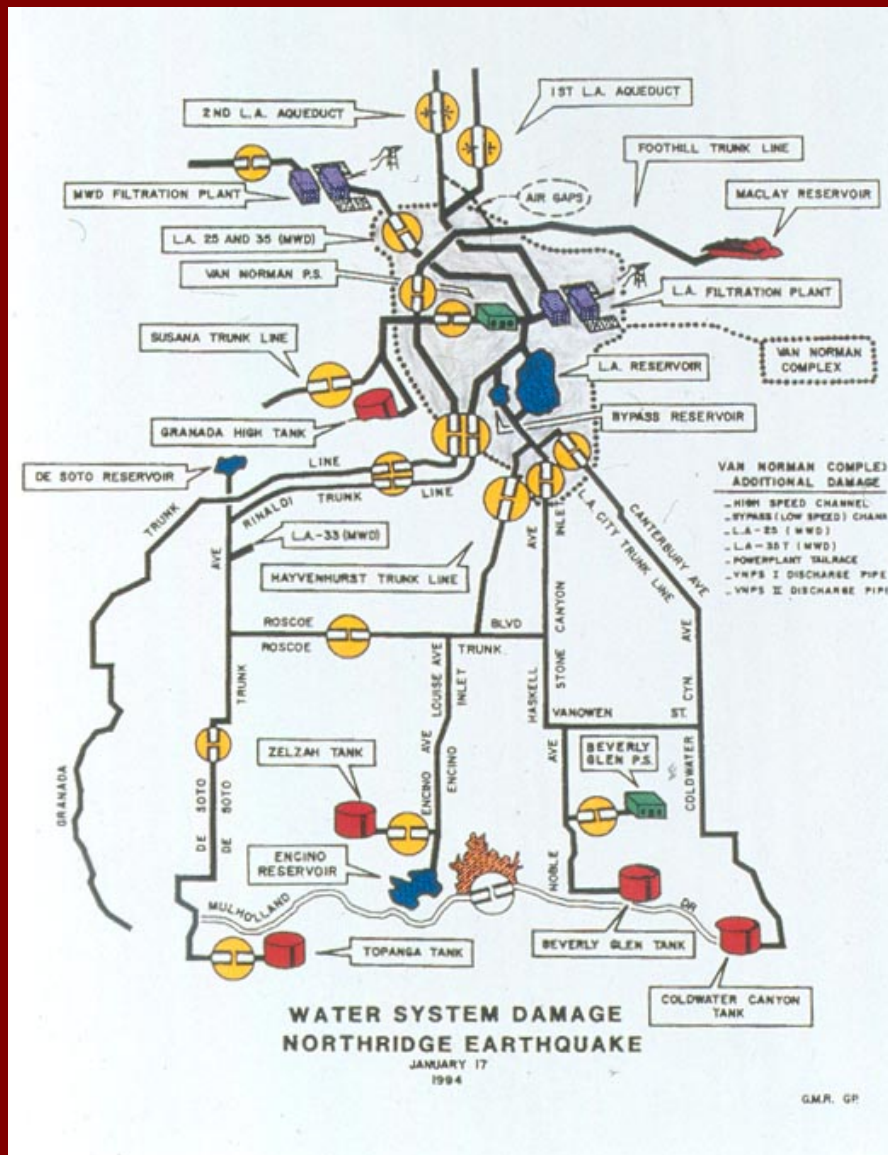
## San Fernando Valley

- Compression or tension bell and spigot joints
- Rigid joints
- Corrosion older steel mains
- Old riveted tanks
- Pumping and chlorinating stations good performance

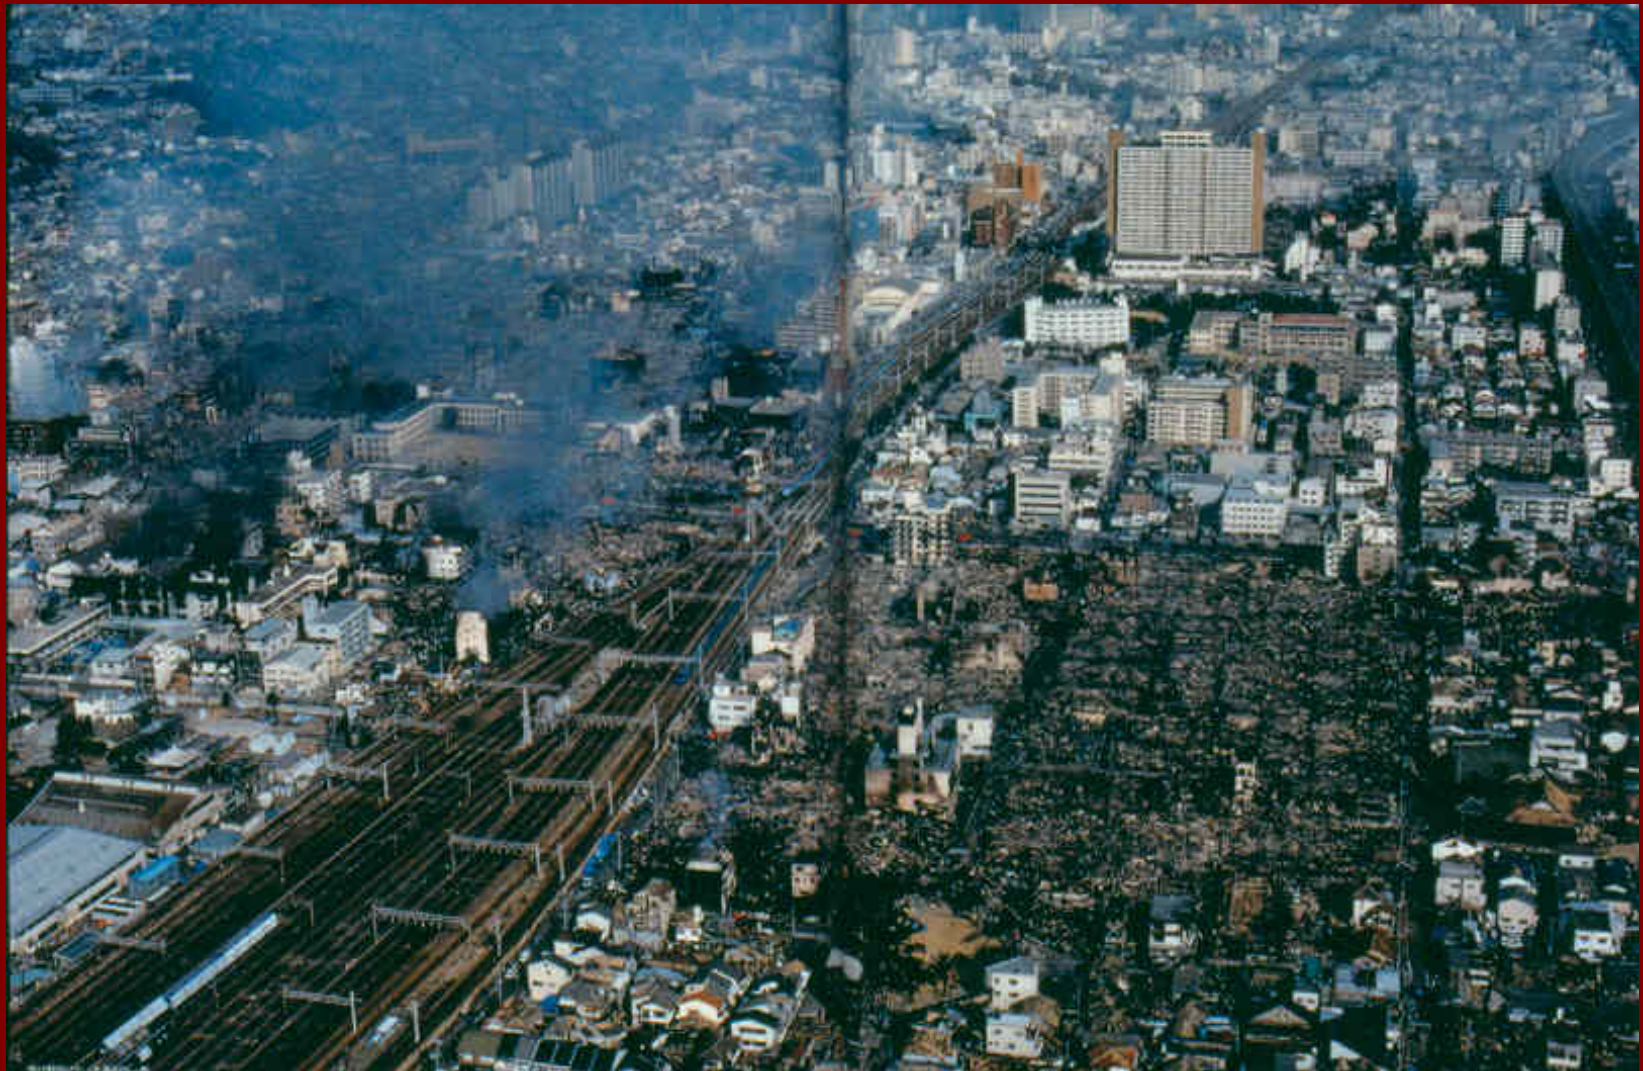
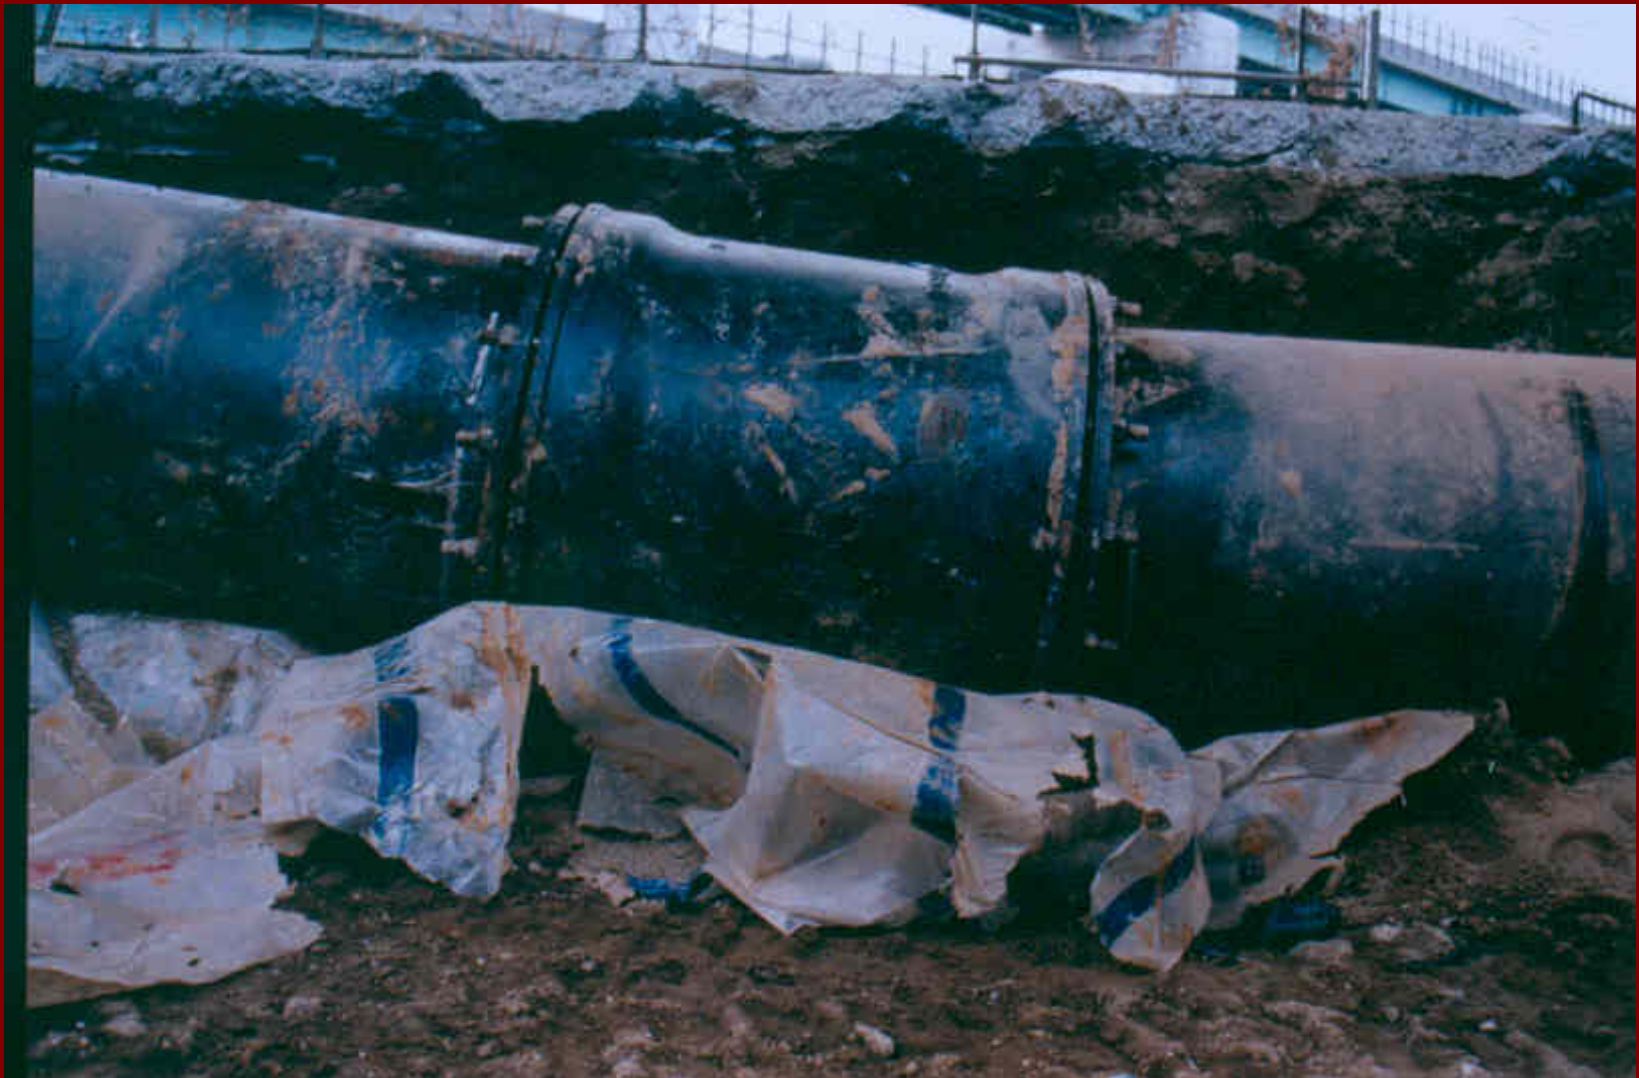
## Kobe

- Cracked pipe body
- Joint failure
- Fitting damage
- Property pipes due to building collapse
- S and S-II joints good performance
- Flexible joints good performance
- Tanks and pumping stations good performance
