Damage to Critical Facilities Following the 921 Chi-Chi, Taiwan Earthquake

by *Tsu T. Soong (Coordinating Author), George C. Yao and C.C. Lin*

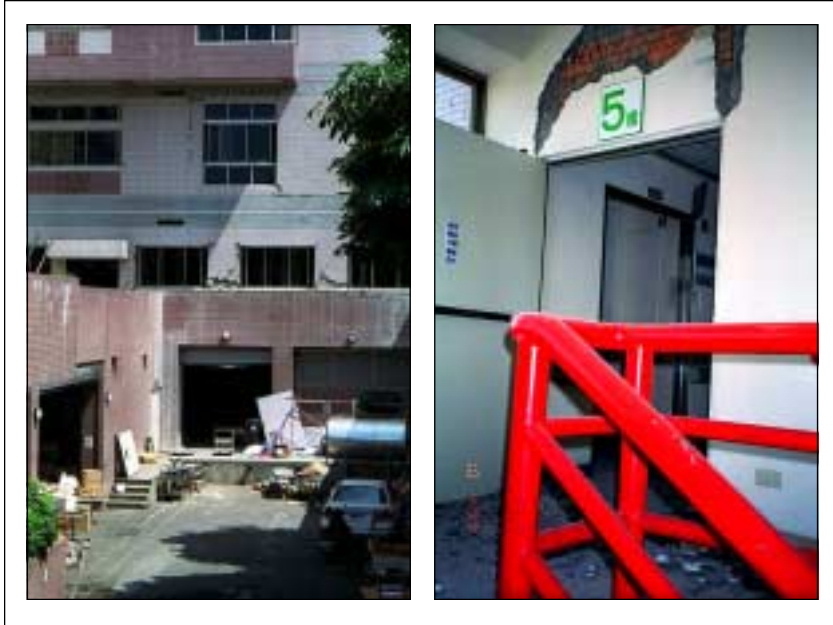
A major facility in Puli and surrounding communities, the Christian Hospital is a 400-bed facility of reinforced concrete (RC) construction consisting of a new (about a year old) section and an old (about 20 years old) section (see Figure 1).

- New section sustained considerable damage from the main event on 9/21/99. Out of safety concerns primarily due to non-structural damage (water damage, equipment failure, etc.), the building was evacuated with patients housed in tents on the hospital grounds. The building was immediately inspected and considered safe. Upon interior cleaning, patients were returned to the building.
- The building suffered significant nonstructural damage again from the 9/27/99 M6.8 aftershock. Patients were again evacuated and housed in temporary trailers with considerably reduced capacity (about 50 beds), with overflow transferred to other area hospitals.

■ **Figure 1.** The Christian Hospital sustained considerable damage. Photos show (left) part of the exterior damage to the hospital; and (right) interior damage to partitions and ceilings.

Restoration was underway. It was estimated that the interior would

be restored and serviceable within two weeks.

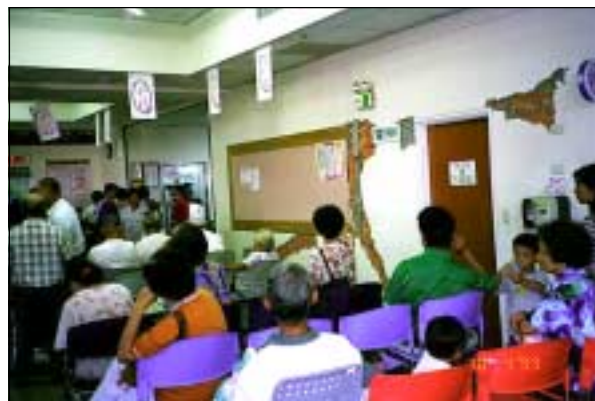
- The first floor of the building remained open and was being used for emergency care, patient registration and processing, command post, and other necessary functions (see Figure 2).

■ **Figure 2.** The first floor of the Christian Hospital remained open though the hospital suffered extensive interior damage.

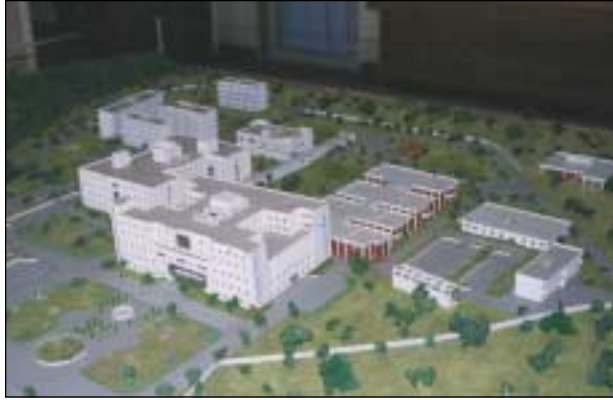
■ **Figure 3.** An overview model of the Veterans Hospital in Puli. The two white buildings are the newest and both sustained considerable damage.

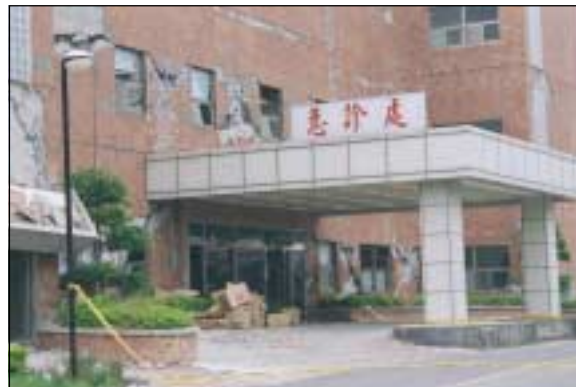
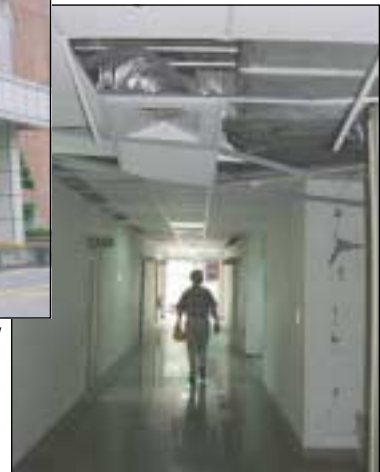
- New buildings sustained considerable damage from the main event. The Medical Building (Bldg. 1) was closed and the patients in the Administration Building (Bldg. 2), along with those in Bldg. 1, were either moved to the older buildings or transferred to other VA hospi-

- Considerable nonstructural damage in Bldgs. 1 and 2, including power failure¹, water damage, and equipment damage. Bldg. 1 also sustained considerable structural damage, probably due to a lack of ductile detailing.

■ **Figure 4.** The Veterans Hospital sustained both exterior damage (left) and interior damage (right) to the newest buildings of the Medical Center.

Whether Bldg. 1 was to be demolished or repaired remained to be determined. Bldg. 2 was expected to be repaired within two weeks.

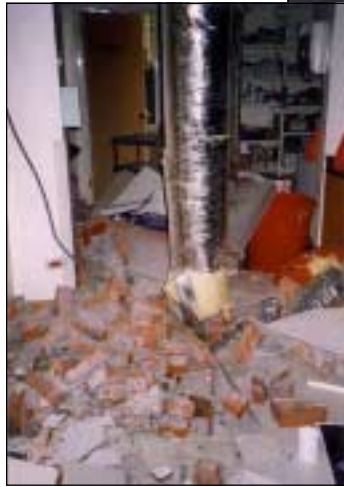
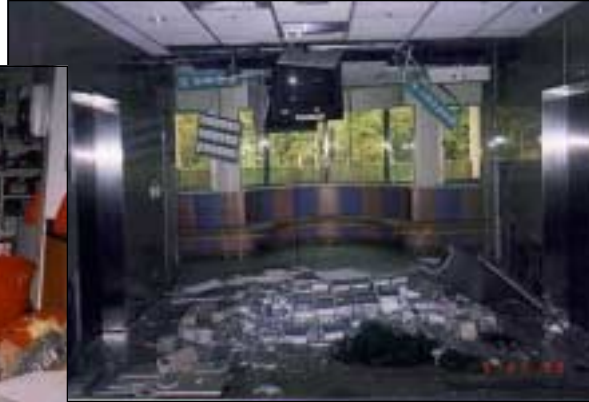
■ **Figure 5.** Interior damage in the Shiu-Tuan Hospital. Shown are (left) fallen brick inside the hospital and (right) a damaged interior glass brick wall.

- Structurally intact, it suffered considerable nonstructural damage as in the case of the other two hospitals (see Figures 5 and 6). Interior damage was most severe at the second- and third-floor levels where, unfortunately, some of the major facilities, such as operating and recovery rooms, were located. Patients were moved to open hospital ground and subsequently transferred to other hospitals.
- Hospital closed.

Repair was underway and the process was expected to take one to two months. Funds for the repair remained to be found.

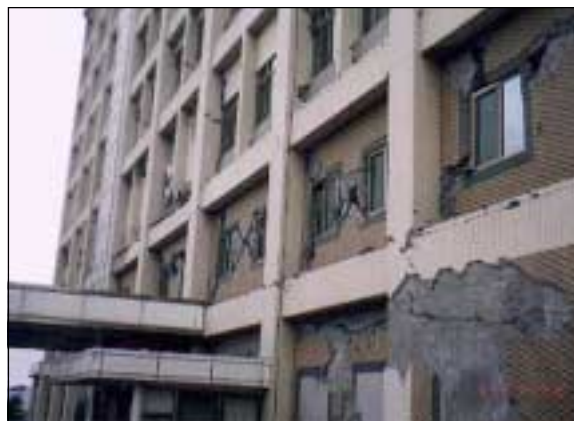
■ **Figure 6.** Damage to an exterior wall of the Shiu-Tuan Hospital in Nantou county

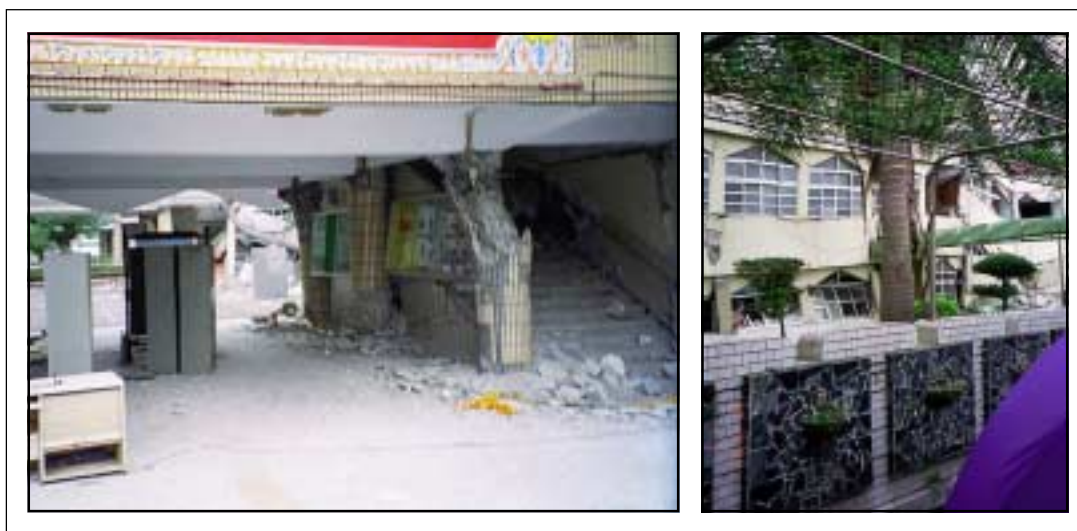
■ **Figure 7.** Typical damage to schools due to short-column effect and eccentricity

- Short-column effects leading to column shear failure.
- Eccentricity due to cantilevered corridors.
- Lack of ductile detailing.
- Column failures due to inadequately spaced stirrups, reinforcements, and splices.
- Soft-story induced failures.
- Unstable foundations and ground uplift.

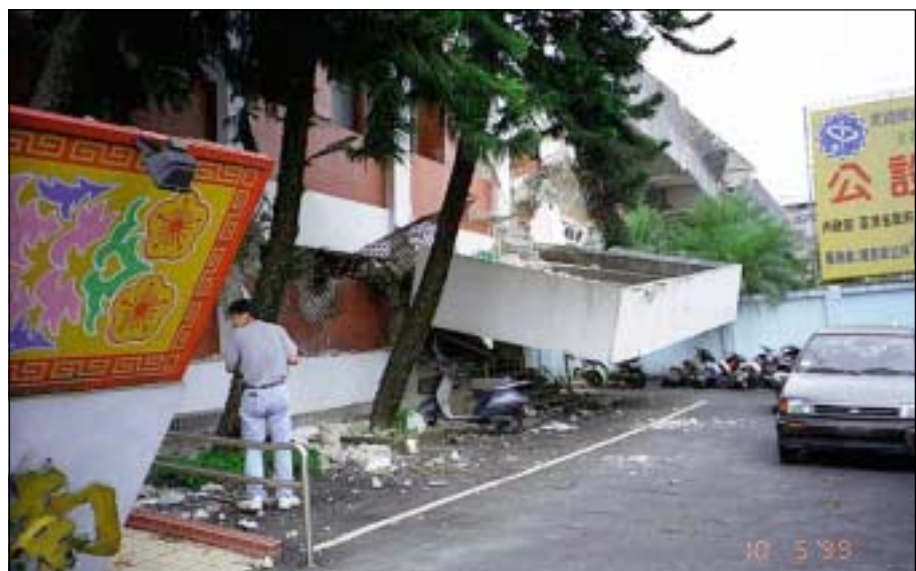
■ **Figure 9.** Heavily damaged Puli Police Station

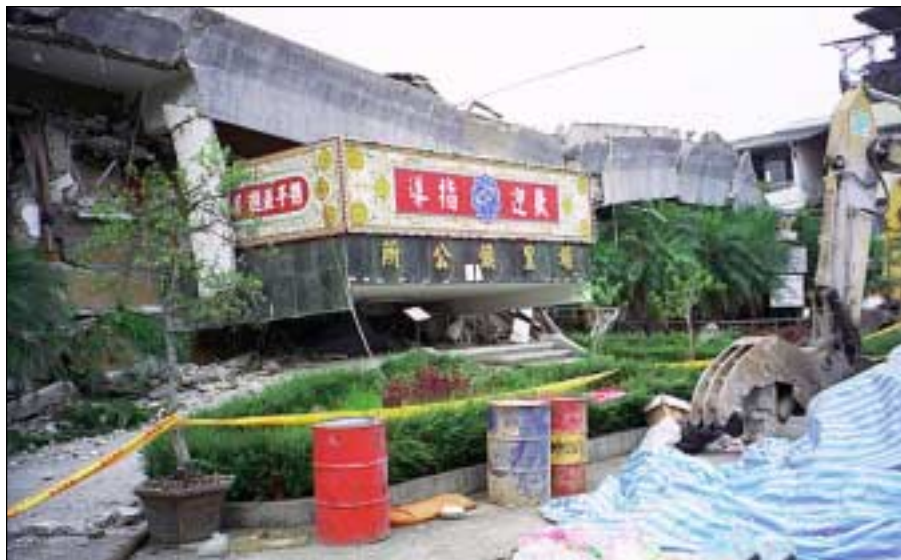
■ **Figure 8.** Total collapse of Puli Town Hall
