## Analysis of a Damaged Building near Ground Zero

Jeffrey Berman and Gordon P. Warn

Department of Civil, Structural & Environmental Engineering, University at Buffalo

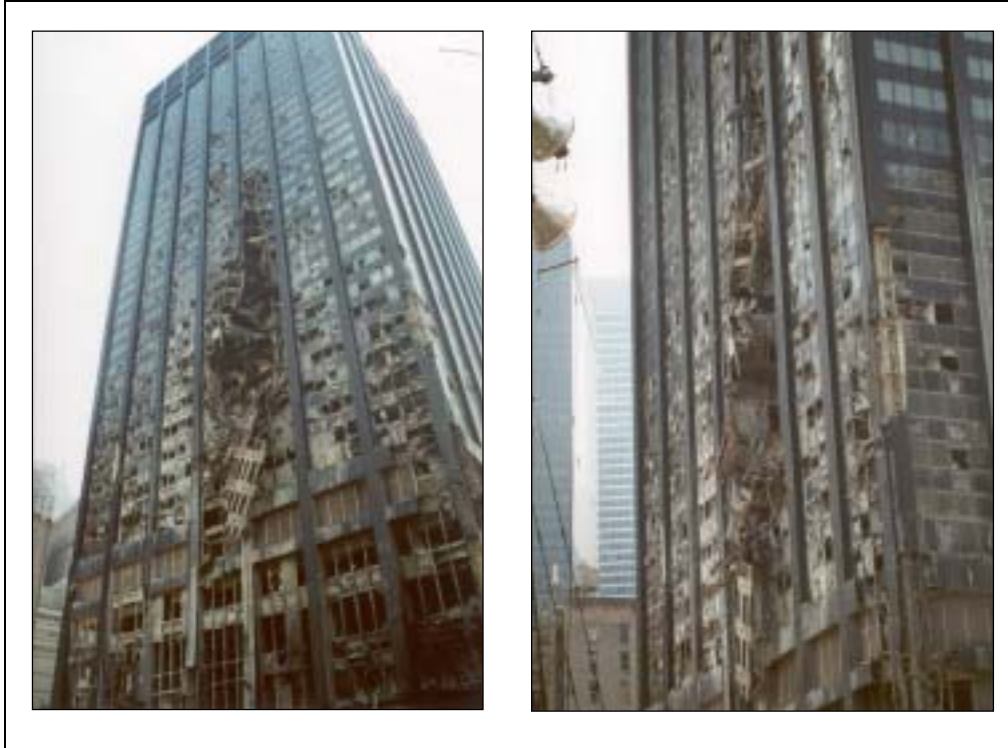
The observation that the subject building did not collapse despite the loss of key structural elements and severe damage (Figure 1) motivated the research team to analyze the building to understand the cause of the observed behavior. Standard tools for linear and nonlinear analysis of buildings subjected to earthquake shaking were employed for these studies. Linear analysis was performed to determine demand to capacity ratios for an undamaged state as well as for three damage states, one of which corresponds to the observed damage. Linear analysis also provided an estimate of the elastic limit of the framing system for each of the damage states considered. Two-dimensional and three-dimensional linear analyses were performed. Small displacement theory was employed for these analyses.

Figure 1. Building damage to northern façade and column on line D

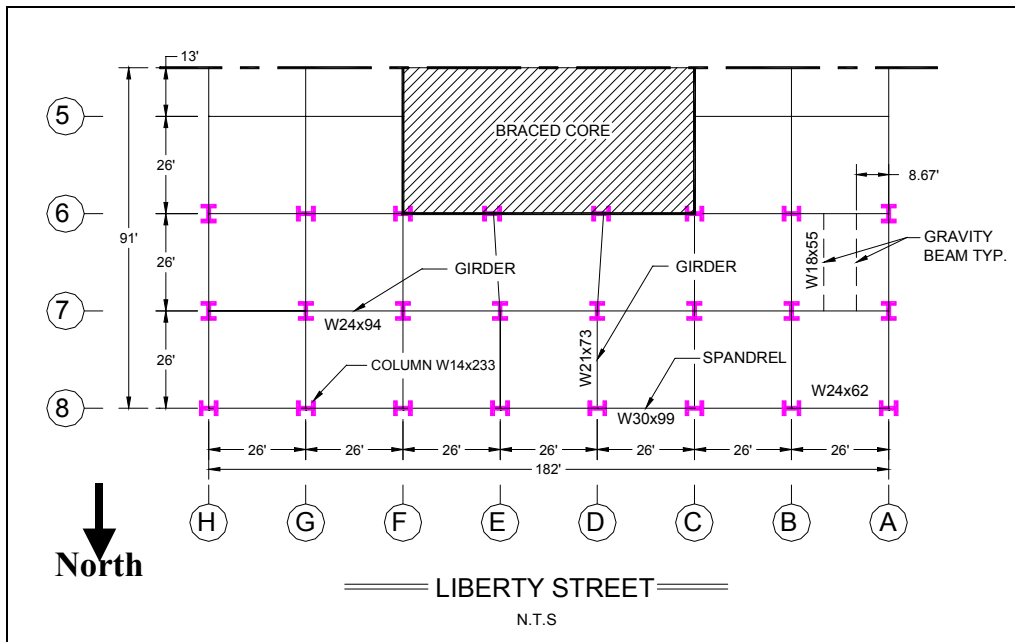
Detailed information on the structural framing system was not available to the research team, although approximate sizes were noted during the building reconnaissance. In order to facilitate linear and nonlinear analysis of the building, sizes of the beams and columns in the moment-resisting frame were estimated by analysis of the building frame for gravity and winds loads as prescribed by the 1970 Building Code of the City of New York (BCCNY 1970). All beam-to-column connections were assumed to be moment resisting. The estimated sizes of the WF beams and columns were checked against the approximate sizes noted during the building reconnaissance. Because no information was available on the steel braced core, sizes were not estimated for the steel braces. Figure 2 shows the resulting section sizes and grid lines on floor 25 just above the damaged section of the building.

Figure 2. Framing on floor 25 and grid lines

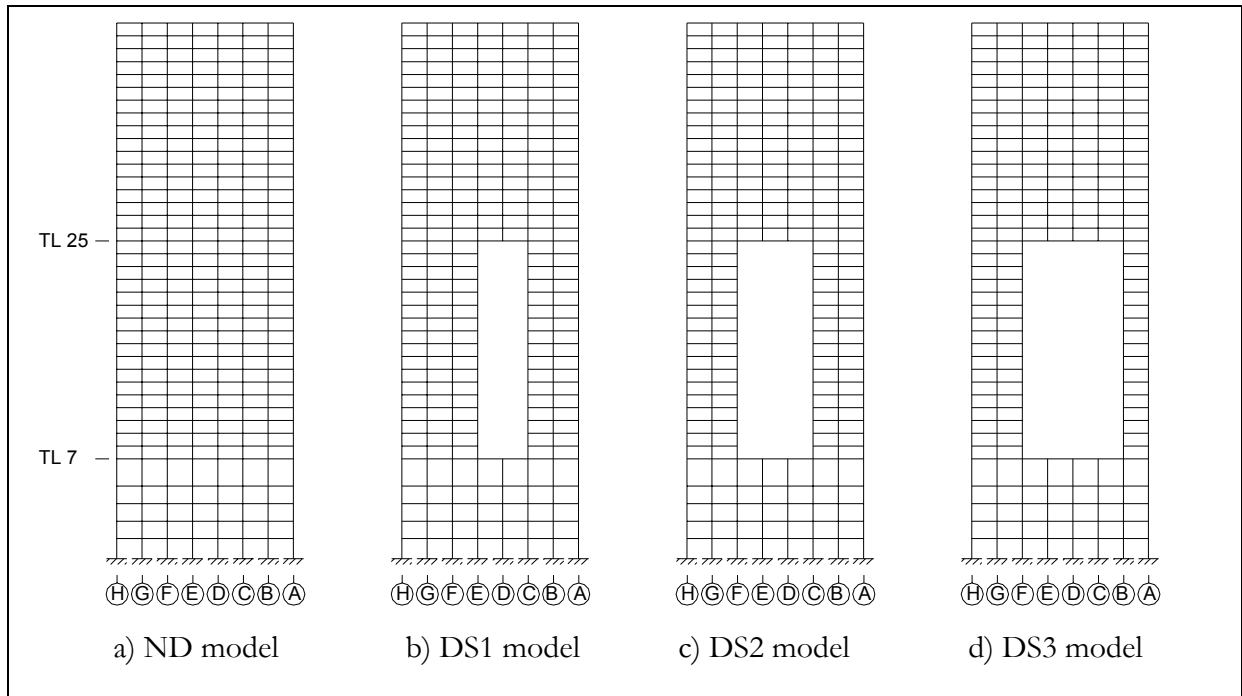
Two- and three-dimensional finite element models were constructed using SAP2000 (CSI 2000). Firstly, a two-dimensional model (Figure 3a) was prepared considering the structural framing over all 39 stories along Line 8 (Figure 2). This model was constructed to study the response of a single frame with varying degrees of damage (or damage states). Secondly, a three-dimensional model was prepared considering the structural framing over all 39 stories along Lines 6, 7, and 8, including intermediate perpendicular framing. This model was prepared to better understand the response of the building for the observed damage state and to compare the results of two- and three-dimensional analysis.

Figure 3. Two dimensional model of framing on line 8

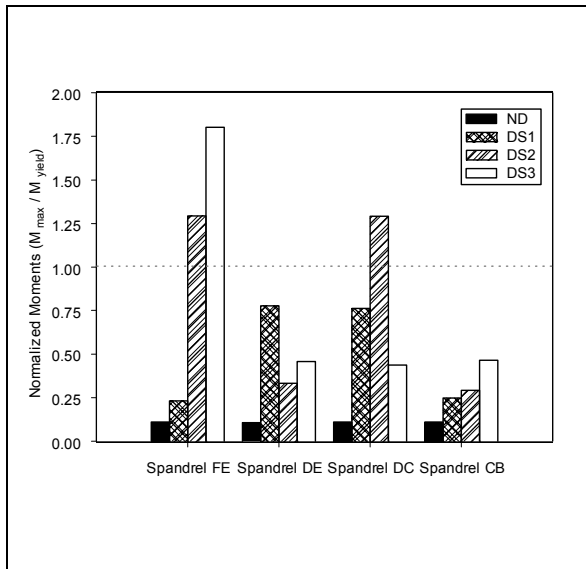
Figures 4 and 5 present some results of the two- and three-dimensional analyses, respectively. Shown in these figures are moments normalized by the yield moment for the assumed beam section sizes at Tenant Level 25 (the floor level immediately above the observed damage). The spandrel beam designation (e.g., DE) refers to the grid lines between which the beam spans (e.g., Lines D and E).

Consider first damage state DS1 (the observed damage) and the two-dimensional analysis. All D/C ratios are substantially less than unity. The three-dimensional analysis shows similar results. These results provide an explanation for the observed behavior of the framing along Line 8 following the impact of debris from Tower 2 and the loss of a column on Line D, namely, that the moment-resisting framing above Tenant Level 25 provided an alternate (redundant) path for gravity loads around Line D and to the foundation without distress of the structural framing. As observed from DS1, models with increasing levels of damage (i.e., DS2 and DS3) show that the moment resisting framing above the damage provided an alternate path for gravity loads. However, for DS2 and DS3, Vierendeel truss action become more apparent.

Figure 4. D/C ratios for 2-D analysis

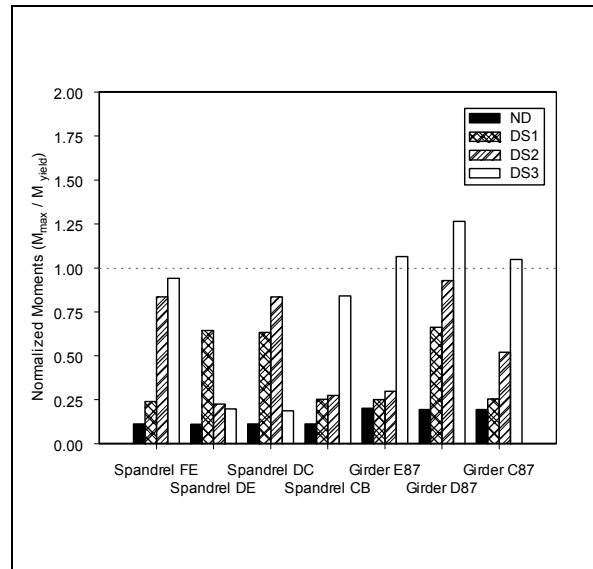
Figure 5. D/C ratios for 3-D analysis

capacity). Review of the three-dimensional analysis results of Figure 5, however, shows that the use of the results of the two-dimensional analysis leads to conservative conclusions and that moment-resisting framing perpendicular to Line 8 also participated in the redistribution of load around the lost columns on Lines D and E. Analyses for both the two- and three-dimensional models of DS3 (the loss of columns on Lines C, D, and E) show modest overloads in both instances. For the three-dimensional analysis, the D/C ratios are greatest in the framing perpendicular to Line 8, namely, Girders C87, D87, and E87.

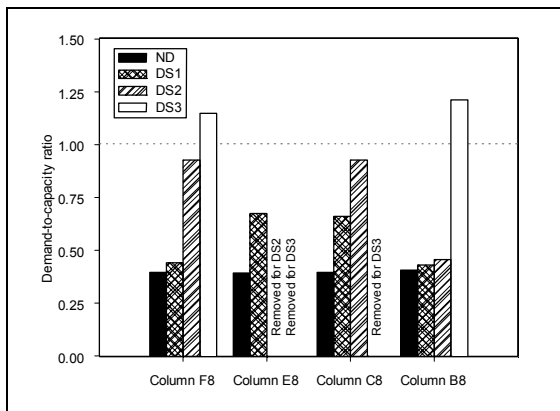
Results of the two-dimensional analysis shown in Figure 6 indicate D/C ratios less than unity for the undamaged state ND and the damage states DS1 and DS2. For damage state DS3, the D/C ratios for columns F8 and B8 exceed unity. Ratios greater than unity can be attributed to an increase in both axial forces and moments due to the removal of columns C8, D8 and E8. This observed increase in bending moment for the two-dimensional analyses ranged from essentially zero for ND to approximately  $0.25 M_p$  (plastic moment of section) for DS3. Noting that the span between adjacent columns for DS3 is four times the span in the undamaged state ND, an increase in moment demand is expected. The D/C ratios for the three-dimensional model (Figure 7) are less than unity for ND and DS1, DS2, and DS3. Again, results of the three-dimensional analysis indicate that the use of two-dimensional analysis leads to conservative conclusions and that the presence of perpendicular framing provides additional redundancy and capability for gravity loads to be redistributed to adjacent framing.

Figure 6. D/C ratios for 2-D analysis

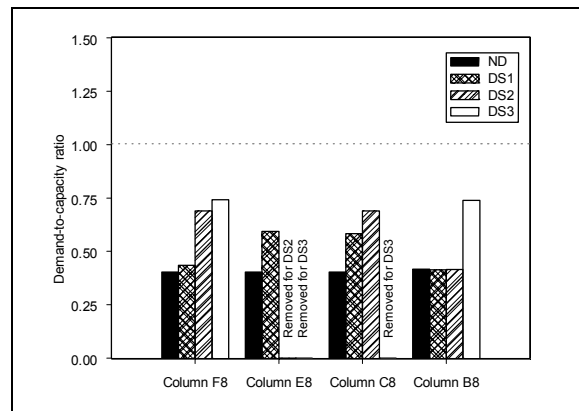
Demand-to-capacity ratios were calculated for columns on Line 8 between Tenant Levels 24 and 25 (Figure 3) for both two- and three-dimensional analyses. The column designation (e.g., F8) in Figures 6 and 7 refers to the column between Tenant Levels 24 and 25 at the intersection of Lines F and 8. Shown in Figures 6 and 7 are column D/C ratios. These ratios were calculated using the nominal strength equation for members under combined forces included in the 1998 Edition of the AISC Manual of Steel Construction, Load and Resistance Factor Design (AISC 1998). To facilitate calculation of D/C ratios and comparison of analysis results, the value of the effective length factor was assumed equal to 1.0 for all columns. This value is the largest assuming that side-sway is prevented, which is a reasonable assumption for the moment frame when considering the lateral stiffness of the braced core (significantly greater than that of the moment frame) and the presence of rigid floor diaphragms.

Figure 7. D/C ratios for 3-D analysis
