Tri-Center Field Mission 2002: Taiwan

Diego Lopez Garcia

Department of Civil, Structural & Environmental Engineering, University at Buffalo

Summary

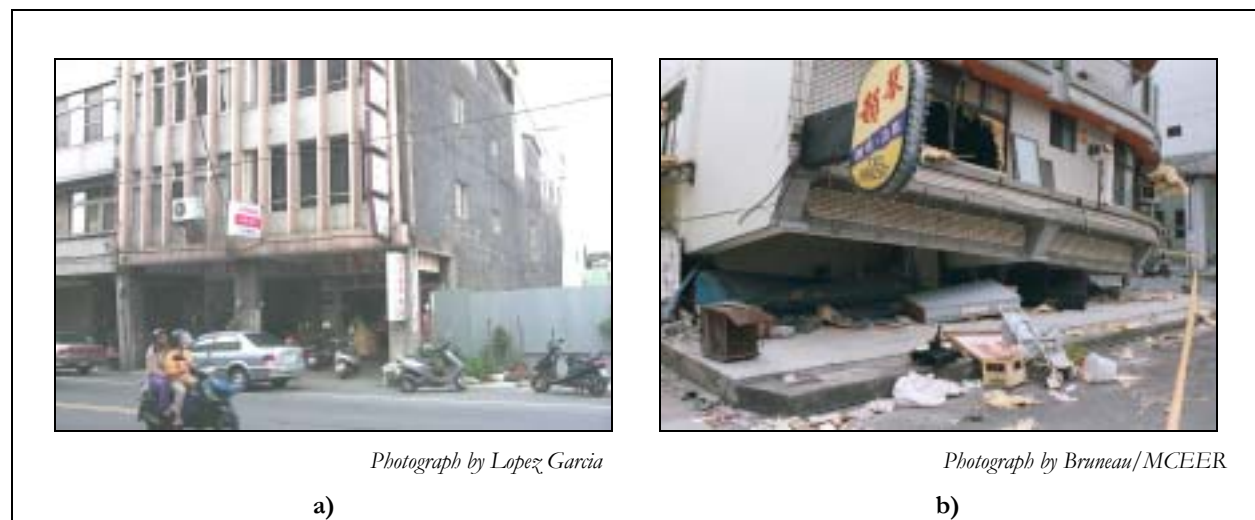
The typical residential building in Taiwan is a 2-to-5-story reinforced concrete frame structure with masonry infill partitions and exterior walls. Since the first story is in most cases occupied by small stores, these buildings have a pedestrian corridor and open front at the side facing the street (Figure 1a). As a result, the first floor is weaker and more flexible than the upper floors, a structural deficiency that is often made worse by the stiffness eccentricity in the direction parallel to the street. These undesirable features were responsible for most of the collapses suffered by these kinds of buildings (Figure 1b). Other deficiencies (short column effect, lack of adequate transverse reinforcement, etc.) also contributed to the poor performance of this type of construction.

Figure 1. Typical residential building in Taiwan: (a) pedestrian corridor and open front; (b) soft story damage

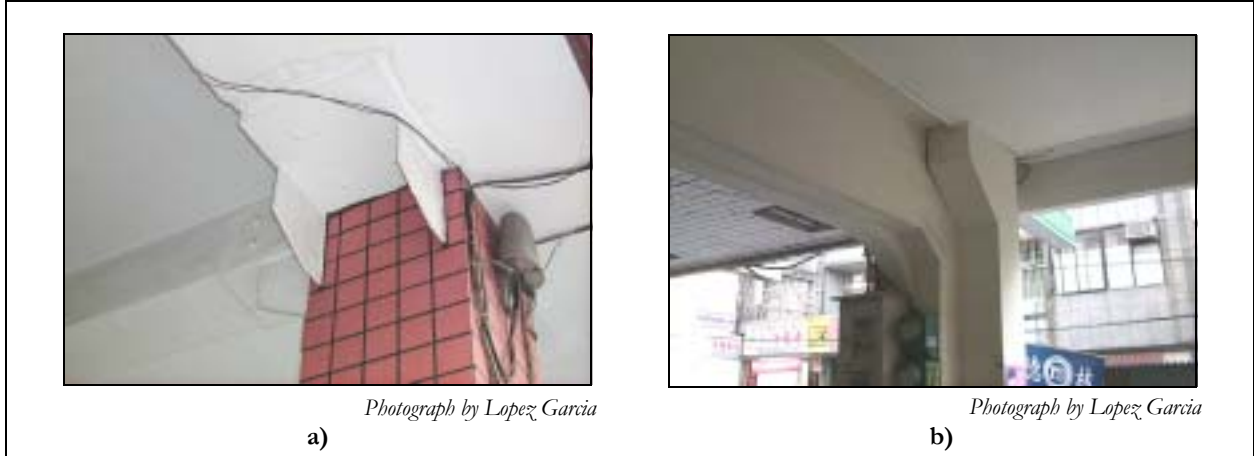
Figure 2. Non-engineered retrofit of residential buildings: (a) beam-column joint retrofitted with steel plates; (b) structure strengthened by a new column

Most of the buildings that did not collapse but suffered some damage have been repaired (Figure 2a) and many more have been retrofitted, mainly by incorporation of new structural members (beams and columns). In most cases, these new structural members are steel elements (Figure 2b, Figure 3). Unfortunately, the majority of these retrofit measures are non-engineered and their utility in improving the seismic behavior of typical residential buildings is difficult to evaluate.

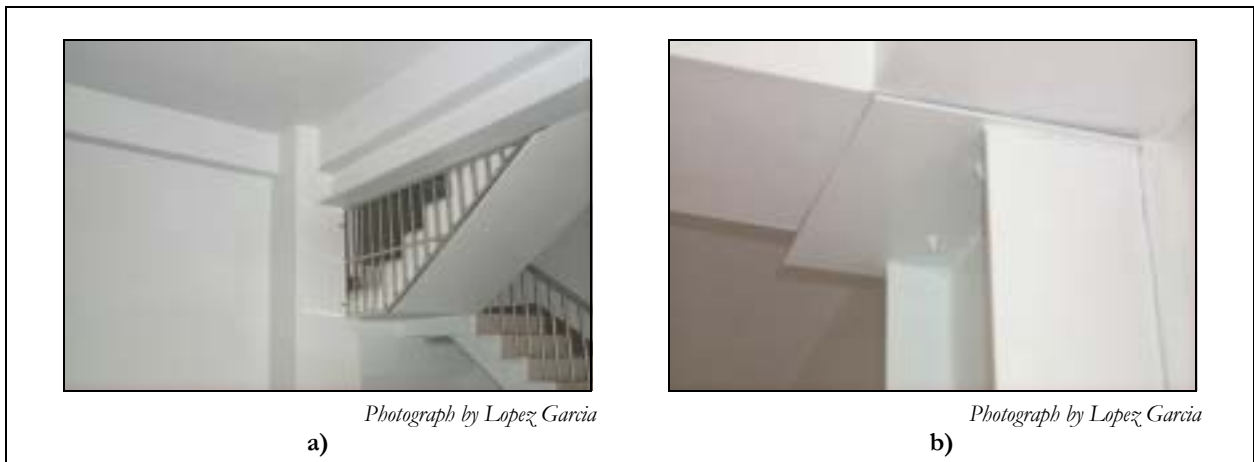
Figure 3. Non-engineered retrofit of residential buildings: (a) RC beam strengthened by a steel beam; (b) eccentric RC beam-column joint supported by a steel column

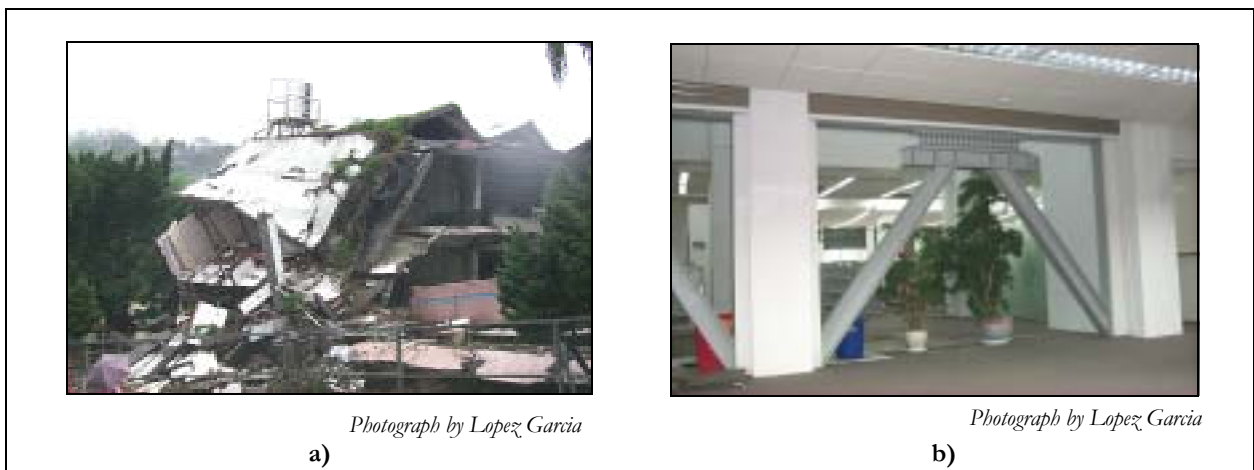
School buildings were also severely affected by the Chi-Chi earthquake and many of them collapsed (Figure 4a). An example of retrofitting measures can be seen in Figure 4b, where metallic dampers have been added to an existing steel structure. Figure 5 shows a new school building under construction, where frames are made up of composite RC-steel members.

Figure 4. (a) Collapse of school building; (b) Library building retrofitted with metallic dampers

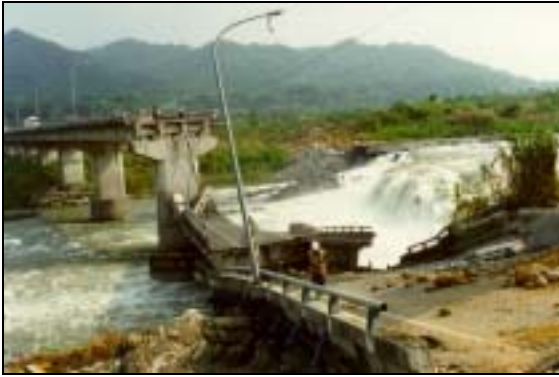
a)

The Chi-Chi earthquake caused many bridge structures to collapse. Many bridges were directly affected by surface rupture and the consequent ground movement. These bridges collapsed due in large part to unseating of one or more simply supported spans (Figure 6a, Figure 7a), which was the typical structural configuration for bridges in service at the time of the earthquake. Other kinds of failures were also observed (Figure 8a). These bridges have been reconstructed, either partially (Figure 6b) or totally (Figure 7b, Figure 8b). An example of partial reconstruction is the Bei-Feng bridge (Figure 6), where some of the original columns were not demolished and were used to support the new bridge. The slope of part of the new bridge (Figure 6b) is a consequence of vertical offset. Most of the completely rebuilt bridges have composite decks supported by continuous steel girders (Figure 7b, Figure 8b), which seems to be the preferred structural configuration for new bridge structures in Taiwan. Joints between continuous segments are located at pier locations (Figure 9a) and the superstructure is supported through elastomeric bearings (Figure 9b). Restrainers against both longitudinal and transverse displacements are usually provided at pier and abutment locations (Figure 9).

Figure 6. Bei-Feng bridge: (a) collapse of end spans; (b) after reconstruction

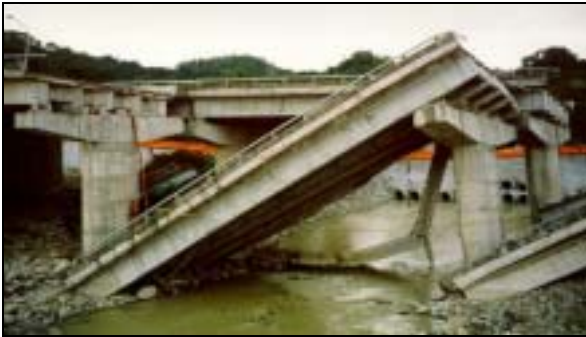
a)

Figure 7. Shi-Wei bridge: (a) collapse of the middle span; (b) after reconstruction

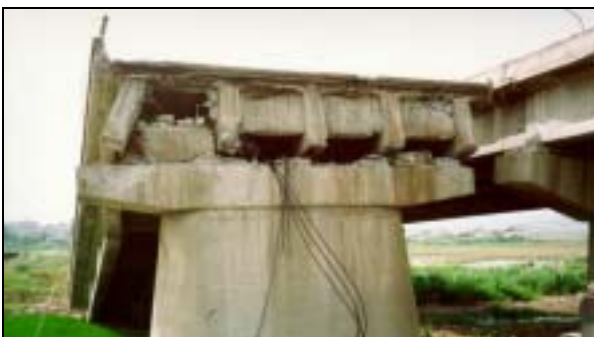
a)

Figure 8. Wu-Shi bridge: (a) diaphragm and shear key failures; (b) after reconstruction

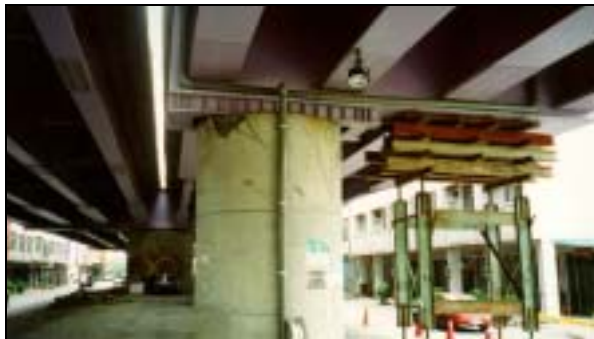
a)

Some bridges not affected by surface rupture were also damaged by strong ground shaking. An example of a repaired bridge structure is shown in Figure 10, where it is shown that a wide column damaged at the connection with the superstructure has been retrofitted by steel jacketing. The column-to-cap beam connection has also been improved by adding steel plates and post-tensioned rods.

Figure 10. Mao-Lou-Shi bridge: (a) distress in eccentric connection; (b) column retrofitted with steel jackets
