**Engineering and Organizational Issues Related to
The World Trade Center Terrorist Attack**

**Reconnaissance and Preliminary
Assessment of a Damaged Building
Near Ground Zero**

**Volume 2:
Reconnaissance and Preliminary Assessment of a
Damaged Building Near Ground Zero**

April 2002

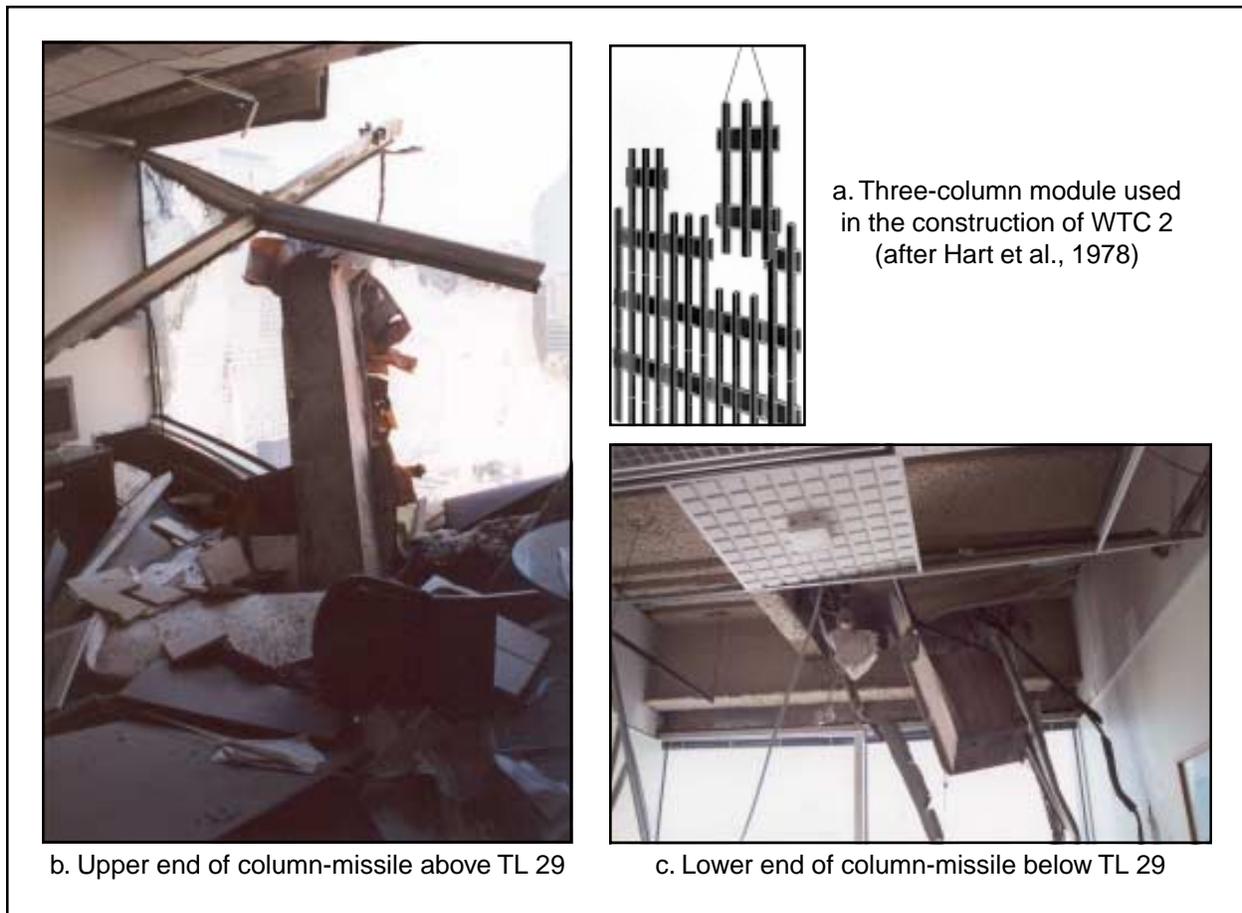
Figure 2.5. Damage due to column-missile ejected from WTC 2

The first major structural damage was observed at TL 29 and was due to the impact of one single-story tall structural steel column from WTC 2. (Note that, as described in Bruneau et al., 2002, this column was one of three in a typical spandrel module, so the two steel beams linking the three columns were destroyed before the single column hit the 130 Liberty Plaza building.) Figure 2.5a is a sketch of a typical three-column module. Figure 2.5b shows the upper end of the column above TL 29. Figure 2.5c shows the underside of the column and the damage it caused to the ceiling system. It is noteworthy that one unreinforced slab on the metal deck arrested the fall of this substantial steel member.

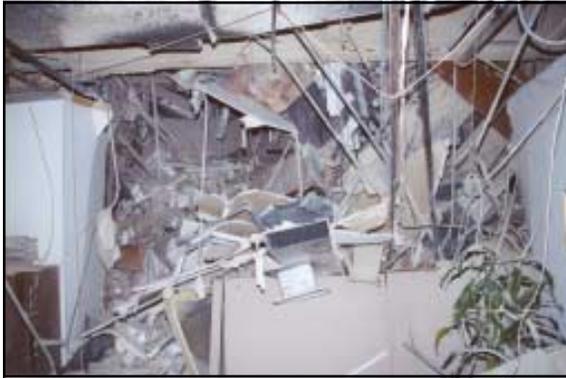
a. Complete destruction of one zone of the building

Figure 2.10 shows the damage at TL 9. Figure 2.10a shows the complete destruction of one zone of the floor immediately adjacent to the northern face of the building. Part b. shows the interior face of the section of WTC 2 façade, seen in Figures 2.1a and 2.9b, that caused much of the damage to the building.
