Location: via Guido Gozzano, city of l'Aquila

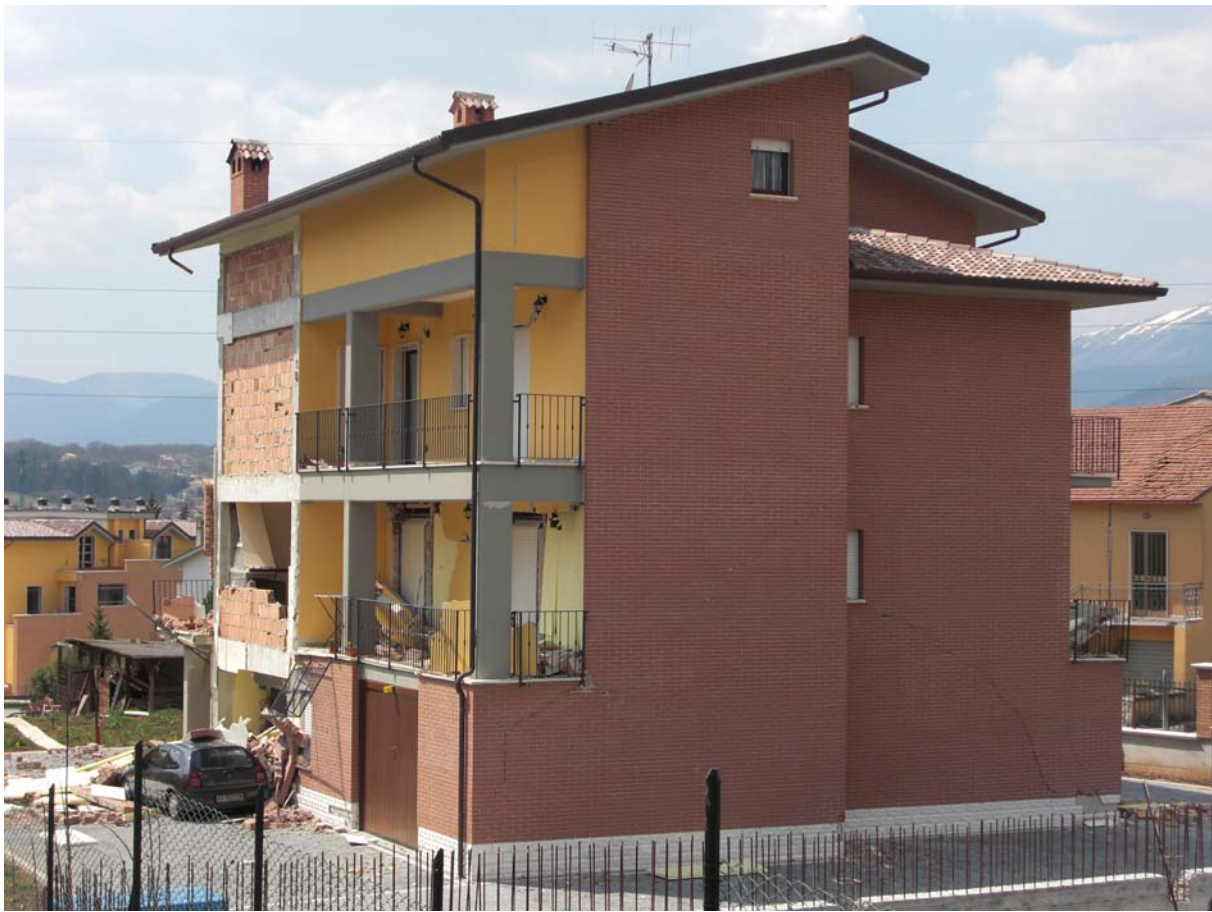
Description: Non-structural damage was observed in a 3-story reinforced concrete building, constructed possibly within the last 5 to 10 years. Similar to what observed in other buildings with the same construction materials, parts of the exterior wall finishes have failed as well as some of the walls at one side of the building.

Fig. 2 Photo of the building after the earthquake. Failure of the exterior facade exposed the exterior walls made of brick. Parts of the exterior walls have collapsed crashing a car parked close to the building.
