Location: via Enrico de Nicola, city of l'Aquila

Description: Damage was observed in a recently constructed 5-story reinforced concrete building.

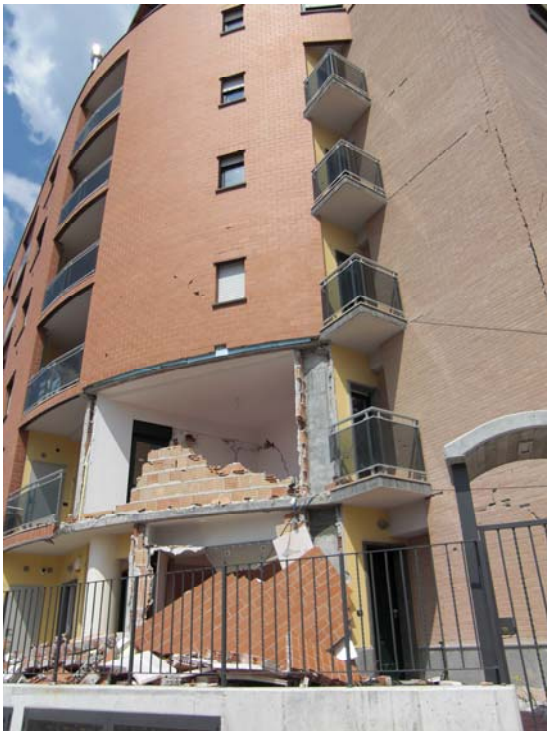
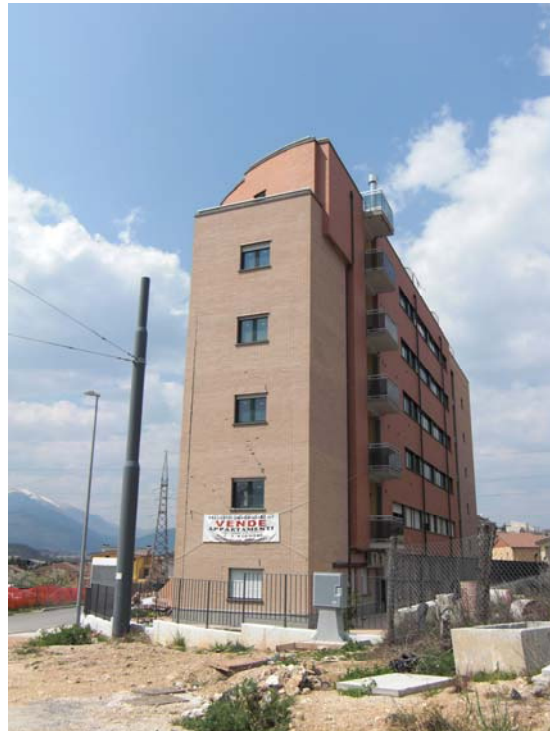
Fig. 2 Failure of the exterior wall at the second floor (left) and cracking of the exterior wall finish in the west side of the building (right)

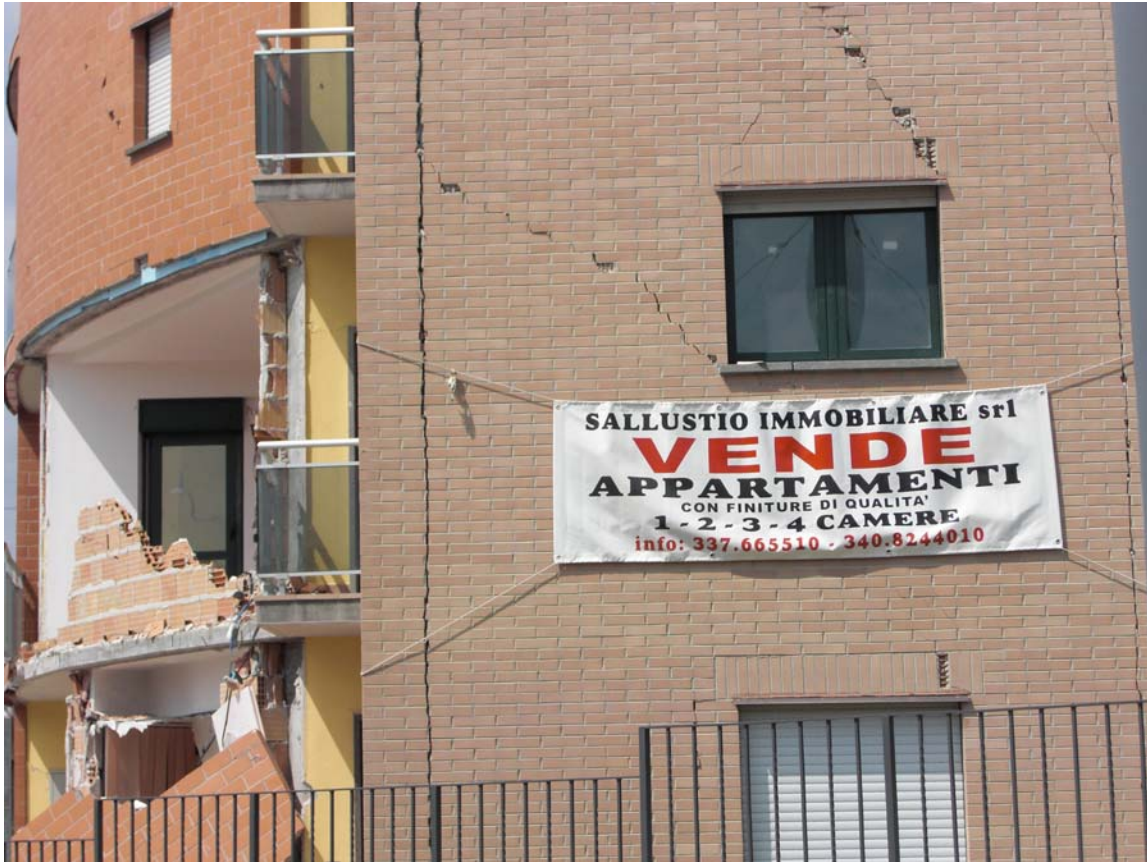
Fig. 3 Close-up view of the diagonal and vertical cracking of the exterior wall finish in the west side of the building
