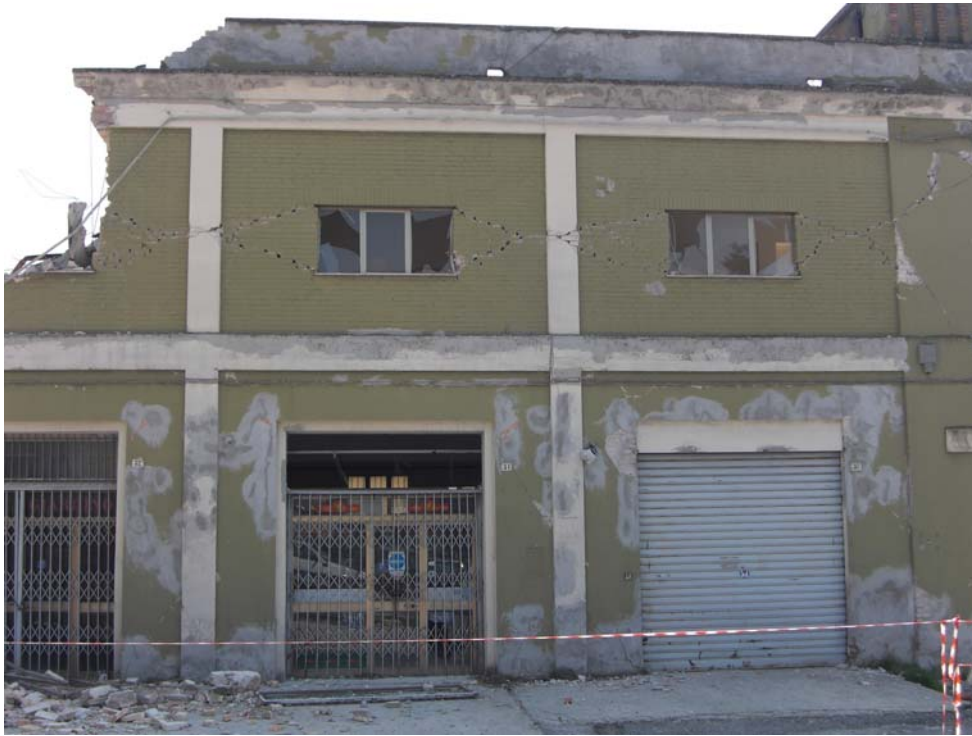
**Fig. 3** Close-up view of the west side of the south part of the building. Diagonal cracking is observed across the corners of the successive windows along the mid-height of the second floor, splitting the concrete columns, as well. The first floor does not appear to suffer from significant damage.

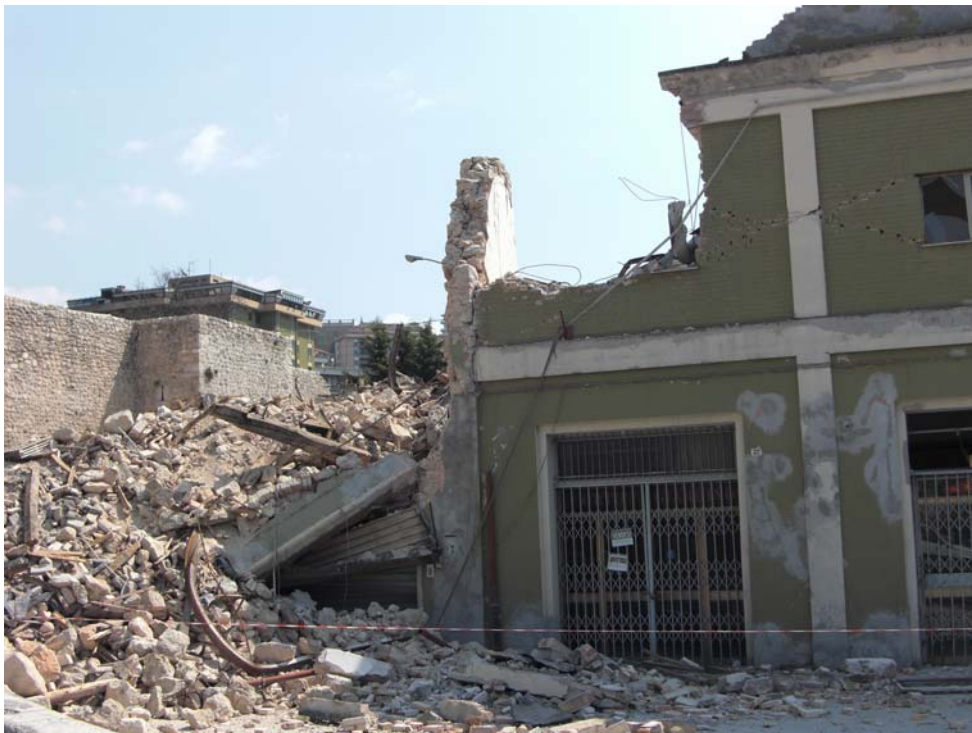
**Fig. 4** Close-up view of the west side of the north part of the building, which has totally collapsed

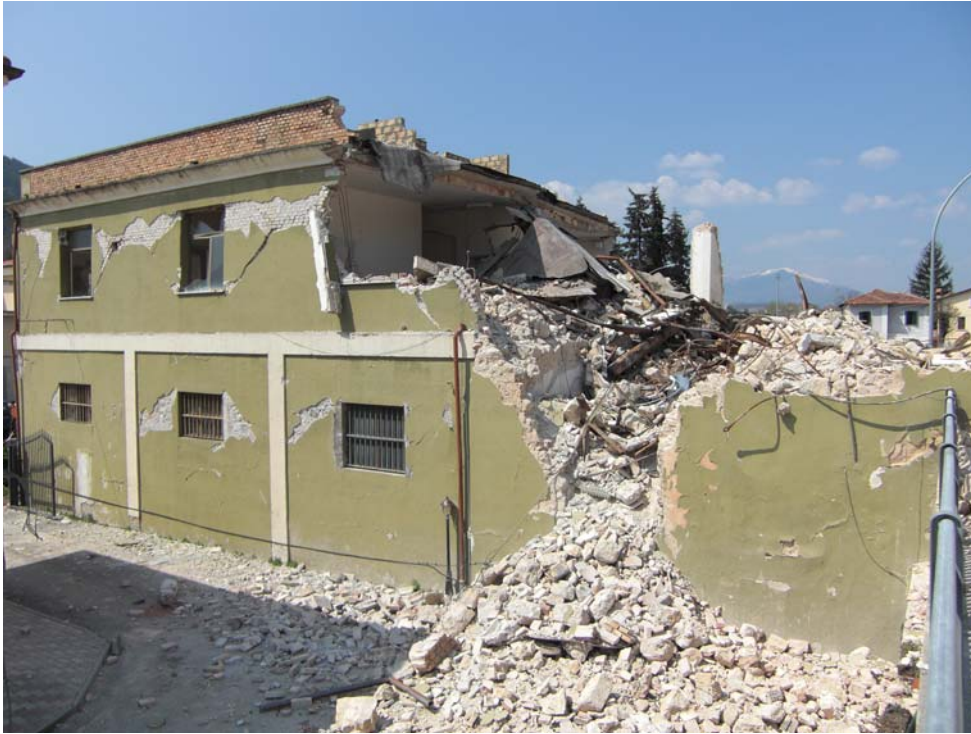
**Fig. 5** View of the east side of the building. Reinforcement in concrete elements appears to be minimal; no longitudinal or transverse reinforcement bars are readily identified in the failed parts of the building

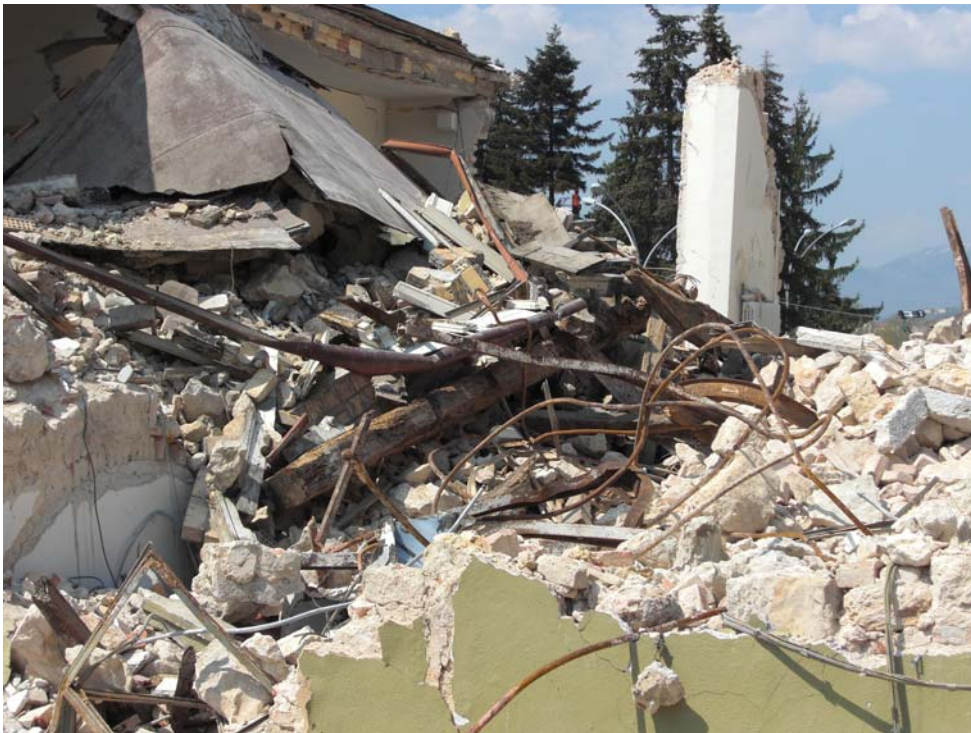
**Fig. 6** Close-up view of the east side of the north part of the building, which has totally collapsed.

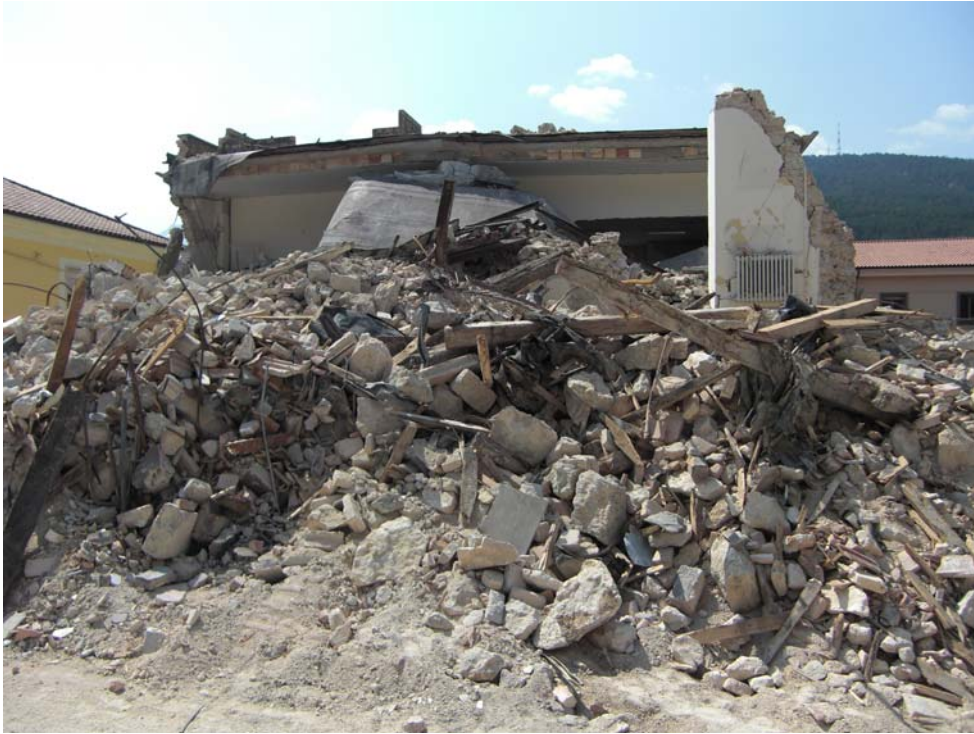
**Fig. 7** Close-up view of the north side of the building. The roof slab appears to be constructed of two thin layers of concrete and bricks. No reinforcement is evident in this photo as well.

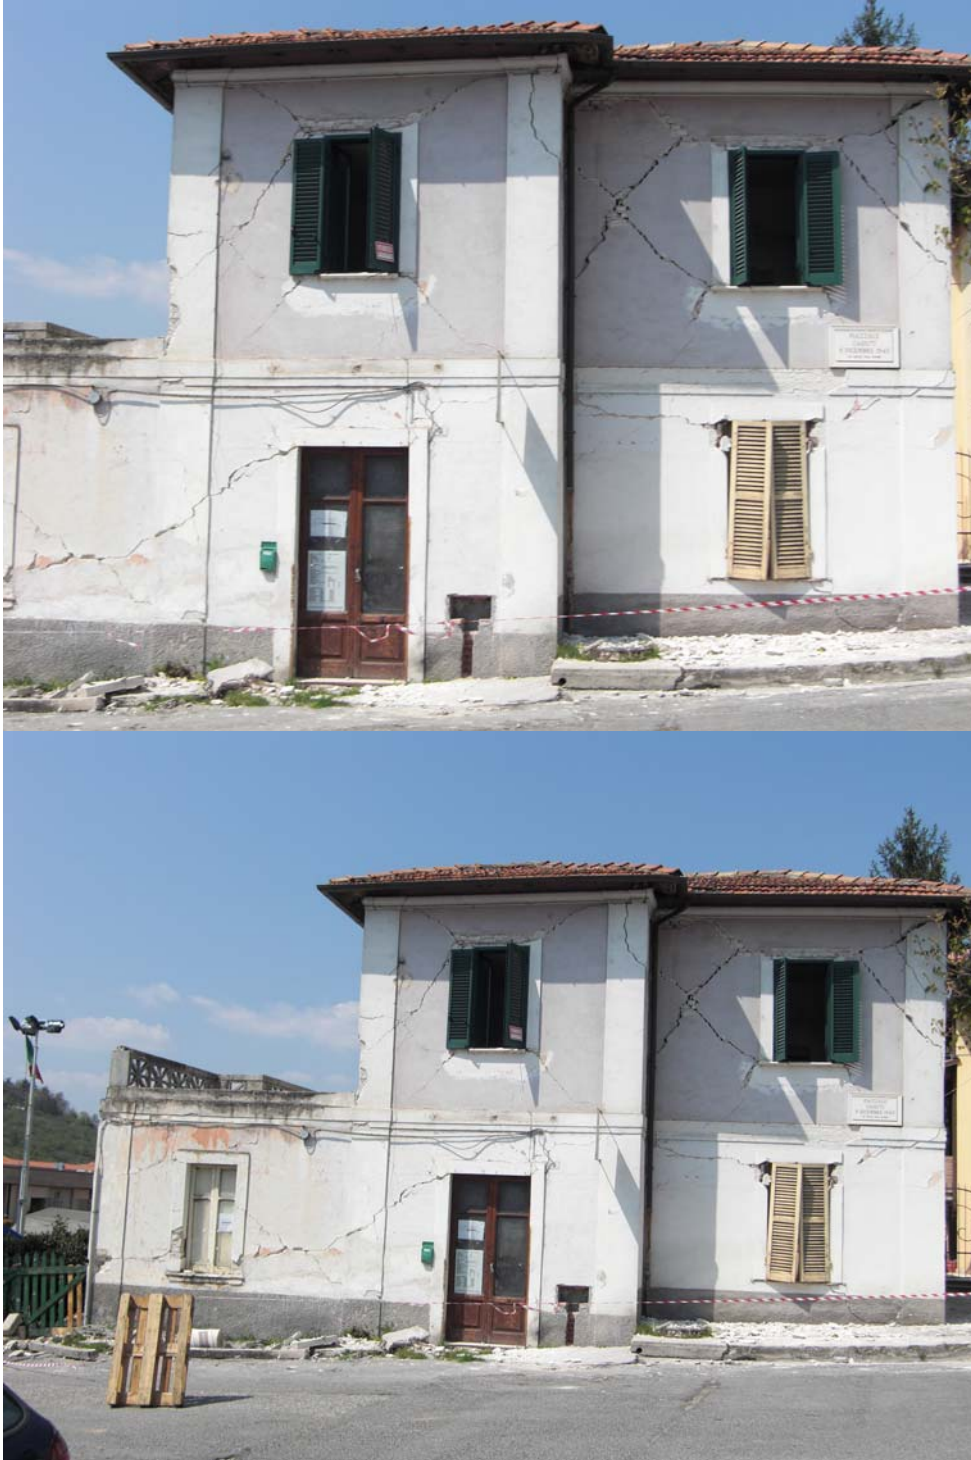
**Building #2:** A two-story building constructed similarly to building 1 (probably non-ductile reinforced concrete, bricks and masonry) has been heavily damaged to an extent that will be probably demolished. The building suffers from evident diagonal cracks that extend along all the exterior walls of both floors. The cracks cross the columns as well.

**Fig. 8** Two photos of the east side of the building. Heavy damage is readily identified, classifying the structure as a collapse hazard

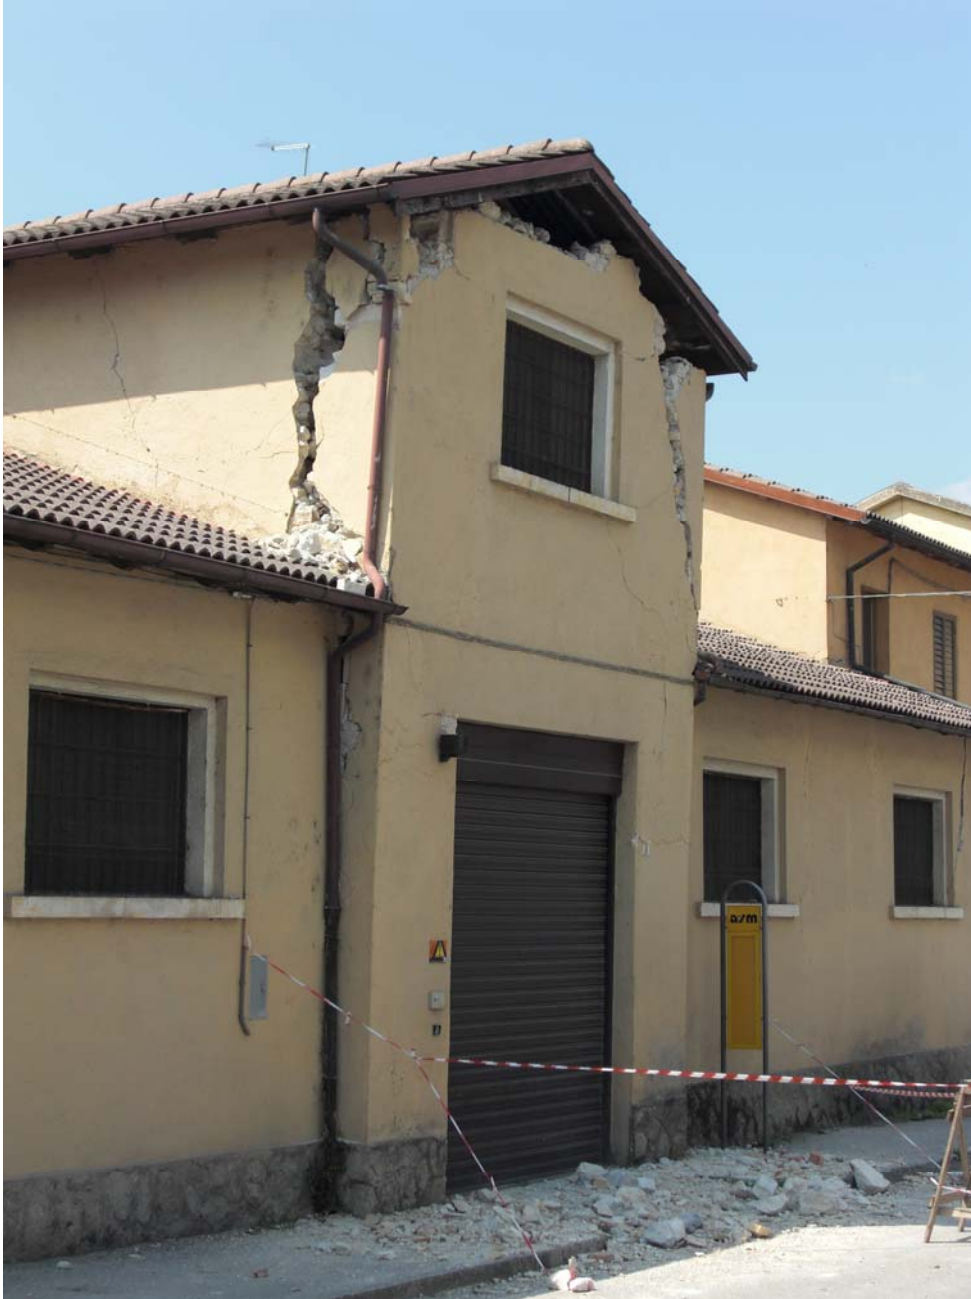
**Building #3:** Heavy damage was observed in a two-story masonry residential house. The middle part of the structure that featured two floors – opposed to the adjacent parts that featured a single floor – has sustained most of the damage. The exterior wall of the second floor has failed out of plane and could expose a collapse hazard in subsequent aftershocks.

**Fig. 9** North-east view of the north side of the building. Fallen debris is identified on the pavement outside the house.

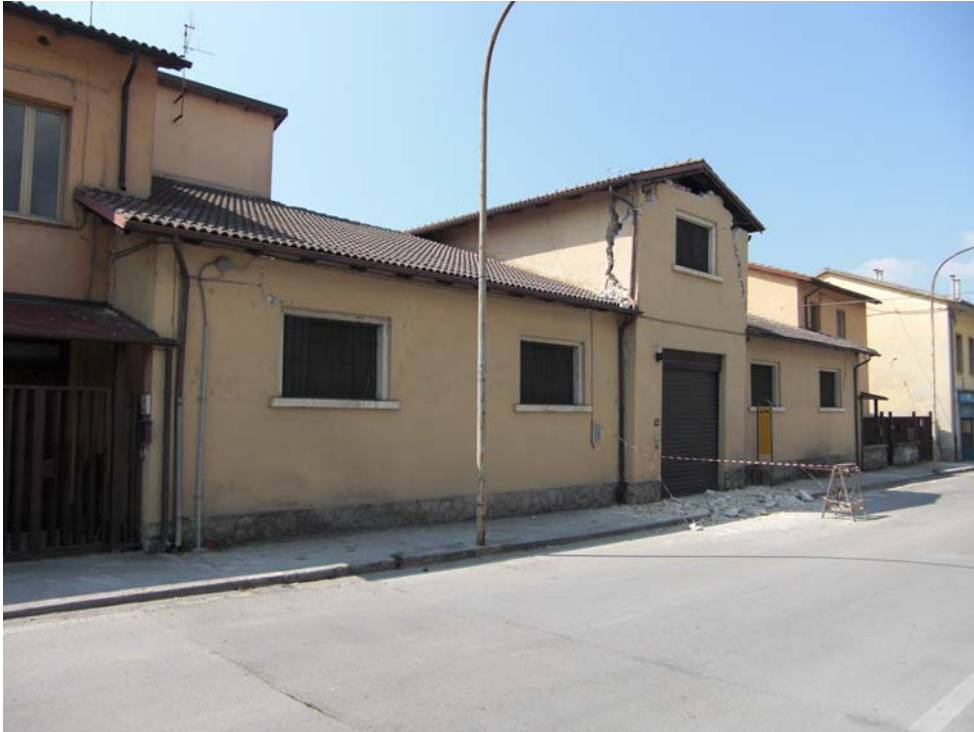
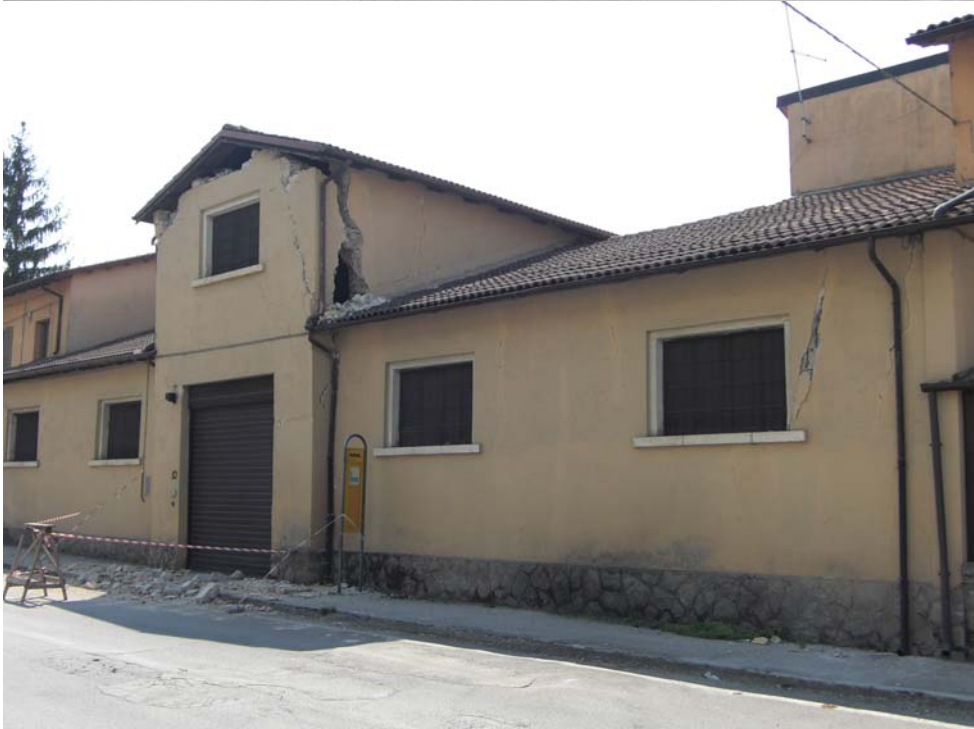
**Fig. 10** General north-east (top) and north-west (bottom) views of the north side of the building. Some cracks can be identified in the adjacent one-story structures, yet no significant damage is evident in these parts of the building.

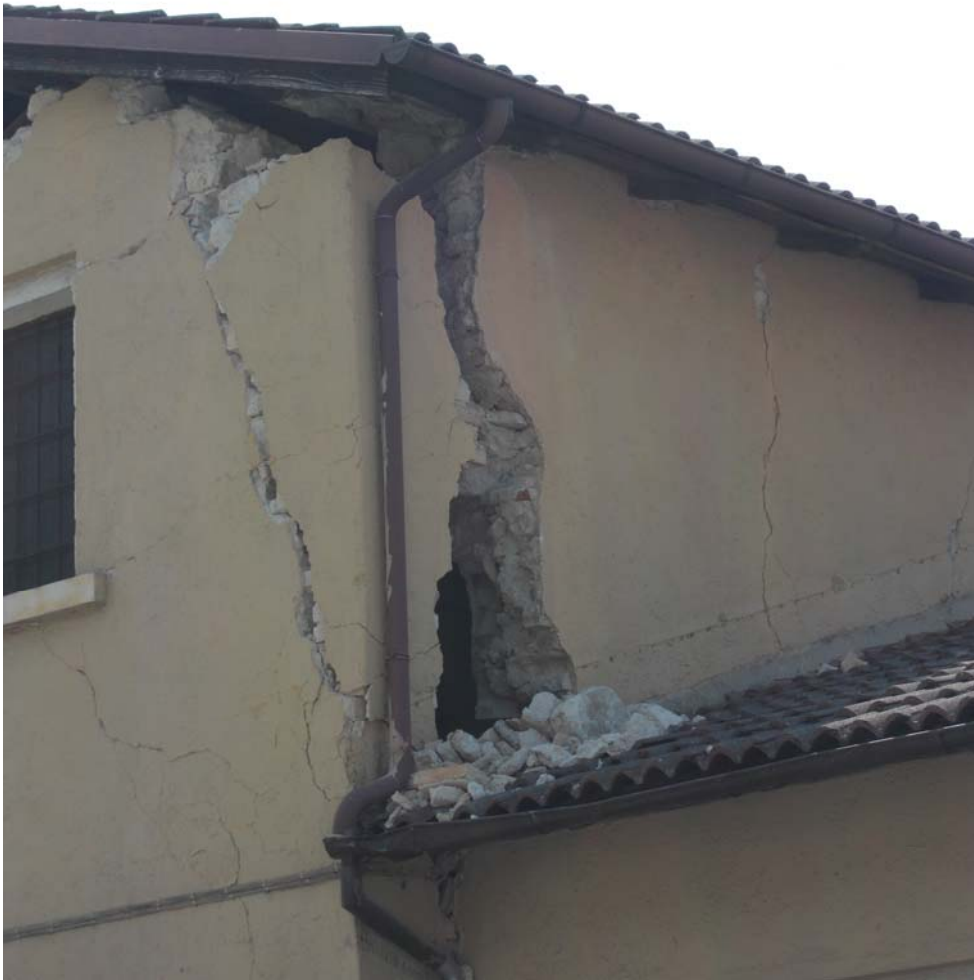
**Fig. 11** Close-up view of the failed part of the exterior wall at the second floor.
