A Summary of Earthquake Reconnaissance Efforts of the National Center for Earthquake Engineering Research

NCEER RESPONSE

Preliminary Reports from the Hyogo-ken Nambu Earthquake of January 17, 1995

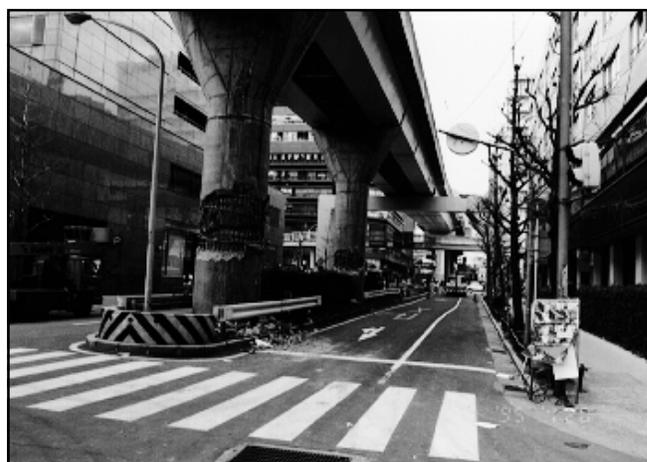
Flexural failure and skewed monorail column. (Photo courtesy of C. Scawthorn.)

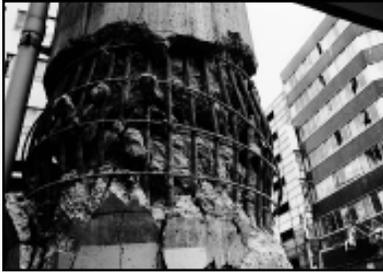
Detail of flexural failure to Monorail column. (Photo courtesy of C. Scawthorn.)

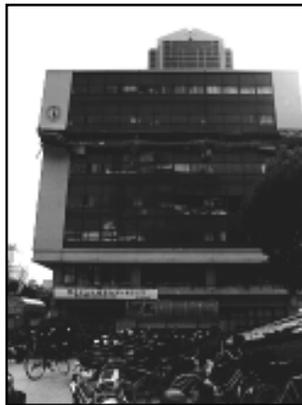
Well in excess of 100 mid-rise buildings constructed during the 1960's and 1970's from reinforced concrete were observed to have failed, in many cases catastrophically. Most failures appear to have been shear failures of columns, which were observed to have very light transverse reinforcement. A number of mid-height single story pancake collapses were observed. An example was the 1960's vintage eight-story Kobe City Hall, which sustained a complete collapse of the sixth floor, while the neighboring 1980's vintage 16-story New City Hall was undamaged.

The sixth floor of the old Kobe City Hall collapsed. (Photo courtesy of C. Scawthorn.)

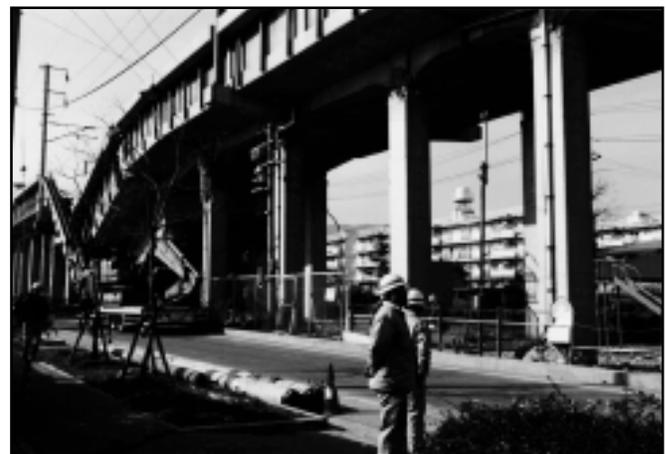
Several spans of the elevated structures supporting bullet train tracks near Shin-Kobe station collapsed at two different sites and a number of bridge piers sustained severe damage apparently through concrete joints. These structures were constructed around 1965 and were reported to have been designed under older design codes. Because of these collapses bullet train operation between Osaka and Okayama will not resume until sometime in May this year, resulting in huge restoration costs and revenue loss to Japan Rail, and causing significant inconvenience to passengers.

A portion of the Shinkansen (Bullet Train) that collapsed during the earthquake. (Photo courtesy of C. Scawthorn.)

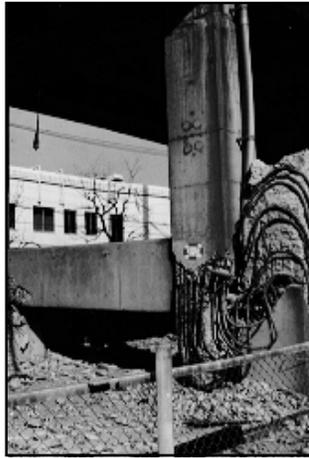
Rail facilities were particularly hard hit in this earthquake (for further information on damage to underground rapid transit facilities, see article by Thomas O'Rourke on page 6). Three main lines (JR West, Hankyu and Hanshin) run through the corridor, in general on elevated embankments, and all sustained embankment failures, overpass collapses, distorted rails and other severe damage. In Kobe, the Shinkansen (Bullet Train) is generally in a tunnel through Rokko Mountain. No information was available regarding the tunnel. At the east portal of the tunnel, the line is carried on an elevated viaduct, built in the 1960's. For a length of three kilometers, this viaduct was severely damaged, with a number of the longer spans collapsing. In general, these collapses were due to shear failure of the supporting columns.

A detailed view of a sheared column which supports the Shinkansen. (Photo courtesy of C. Scawthorn.)

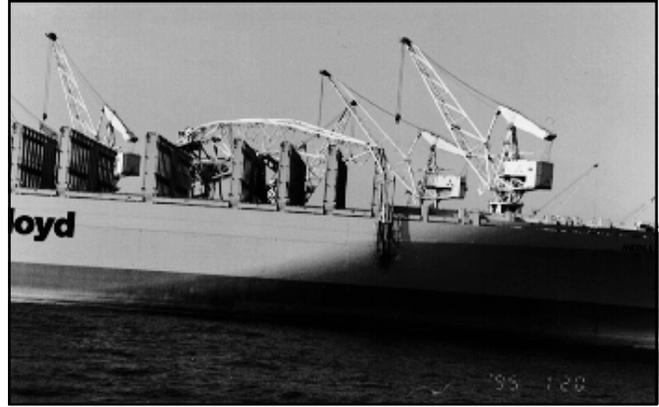
The Port of Kobe, one of the largest container facilities in the world, sustained major damage. Rokko and Port Islands experienced widespread liquefaction and, on Rokko Island, a number of gantry container cranes failed due to crane rail distortions, with one collapse. Shipping in general had to be diverted to other ports (Osaka, Nagoya, Yokohama), while passenger and some vehicle ferry service was gradually established in the days following the earthquake. The Port of Osaka experienced almost no damage.

Crane collapse due to ground subsidence caused by liquefaction. (Photo courtesy M. Hamada.)
