Kocaeli (Izmit) Earthquake of August 17, 1999

The Kocaeli (Izmit) Earthquake

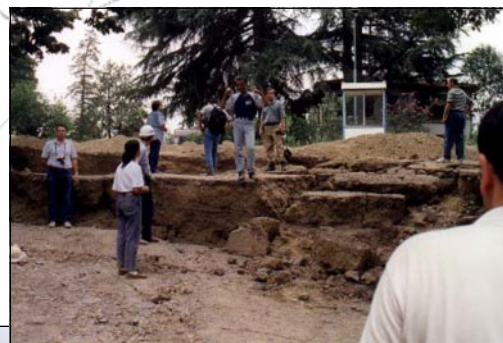
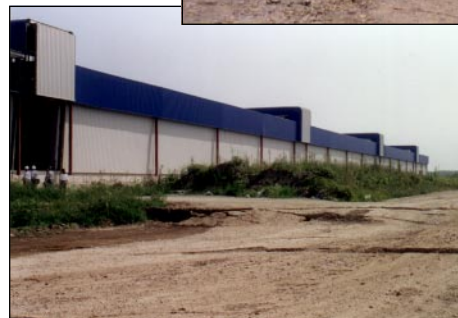
Surface faulting was common near Golcuk (above); the fault rupture is visible next to this damaged manufacturing facility, under construction at the time of the earthquake.
