## DAMAGE TO CRITICAL FACILITIES

by *Tsu T. Soong and George C. Yao*

### HOSPITALS VISITED

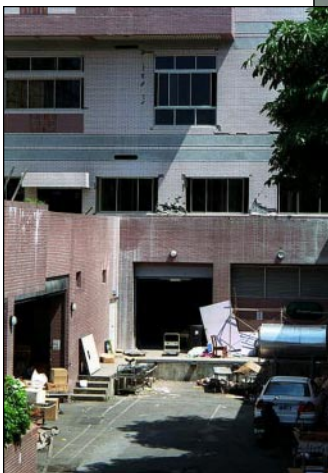
*Figure 1. The Christian Hospital sustained considerable damage. Photos show (left) part of the exterior damage to the hospital; and (above) interior damage to partitions and ceilings.*

A major facility in Puli and surrounding communities, the Christian Hospital is a 400-bed facility of reinforced concrete (RC) construction consisting of a new (about 4-yr. old) section and an old (about 20-yr. old) section (see Figure 1).

Restoration is underway. It was estimated that the interior will be restored and serviceable in two weeks.

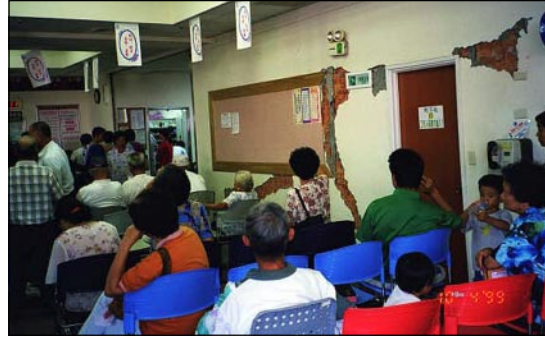
*Figure 2. The first floor of the Christian Hospital remained open though the hospital suffered extensive interior damage.*

- New section sustained considerable damage from the main event on 9/21/99. Out of safety concerns primarily due to nonstructural damage (power outage<sup>1</sup>, water damage, equipment failure, etc.), the building was evacuated with patients housed in tents on the hospital ground. The building was immediately inspected and considered safe. Upon interior cleaning, patients were returned to the building.
- The building suffered significant nonstructural damage again from the 9/27/99 M6.8 aftershock. Patients were again evacuated and housed in temporary trailers with considerably reduced capacity (about 50 beds), with overflow transferred to other area hospitals.
- The first floor of the building remains open and is being used for emergency care, patient registration and processing, command post, etc. (see Figure 2).

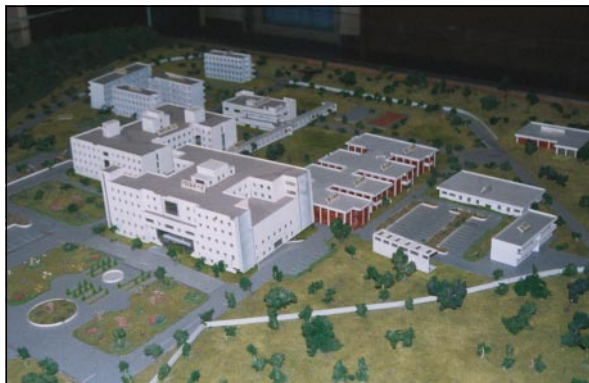
Another major hospital in Puli, the Veterans Hospital is a 450-bed facility with two main RC buildings (the Medical Center and the Administration Center), built about three years ago and several older (about 25-yr. old) and smaller buildings (see Figures 3 and 4).

Figure 3. An overview model of the Veterans Hospital in Puli. The two white buildings are the newest and both sustained considerable damage.

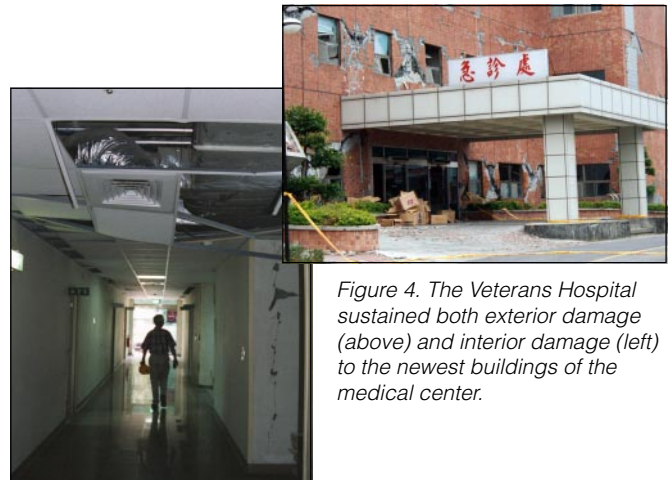
- New buildings sustained considerable damage from the main event. The Medical Building (Bldg. 1) was closed and the patients in the Administration Building (Bldg. 2), along with those in Bldg. 1, were either moved to the older buildings or transferred to other VA hospitals. About 220 patients remain at the hospital.
- Considerable nonstructural damage in Bldgs. 1 and 2, including power failure, water damage, and equipment damage was observed. Bldg. 1 also sustained considerable structural damage, probably due to a lack of ductile detailing.

Figure 4. The Veterans Hospital sustained both exterior damage (above) and interior damage (left) to the newest buildings of the medical center.

Whether Bldg. 1 is to be demolished or repaired remains to be determined. Bldg. 2 is expected to be repaired within two weeks.

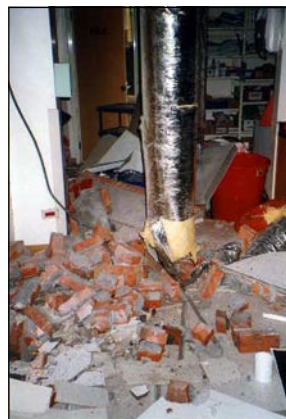
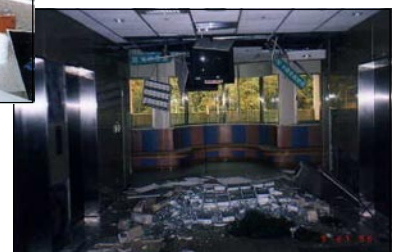
- Structurally intact, it suffered considerable non-structural damage as in the case of the other two hospitals (see Figures 5 and 6). Interior damage was most severe at the second- and third-floor levels where, unfortunately, some of the major facilities, such as operating and recovery rooms, were located.

Figure 5. Interior damage in the Shiu-Tuan Hospital. Shown are (top) fallen brick inside the hospital and (right) a damaged interior glass brick wall.

Repair is underway and the process may take one to two months. Funds for the repair remain to be found.

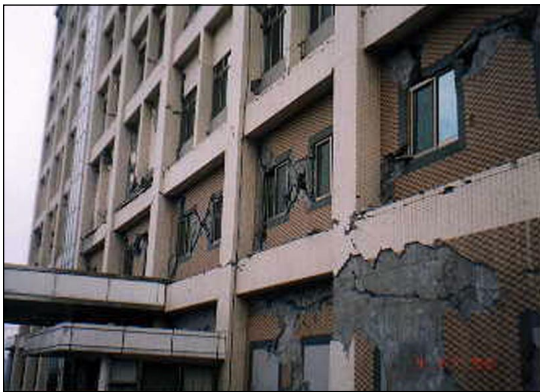
Figure 6. Damage to an exterior wall of the Shiu-Tuan Hospital in Nantou County.
