# Water Distribution Seismic Performance 1994 Northridge-1995 Kobe Earthquakes

Le Val Lund, P. E., Craig Davis, P. E.,  
and Martin Adams, P. E.

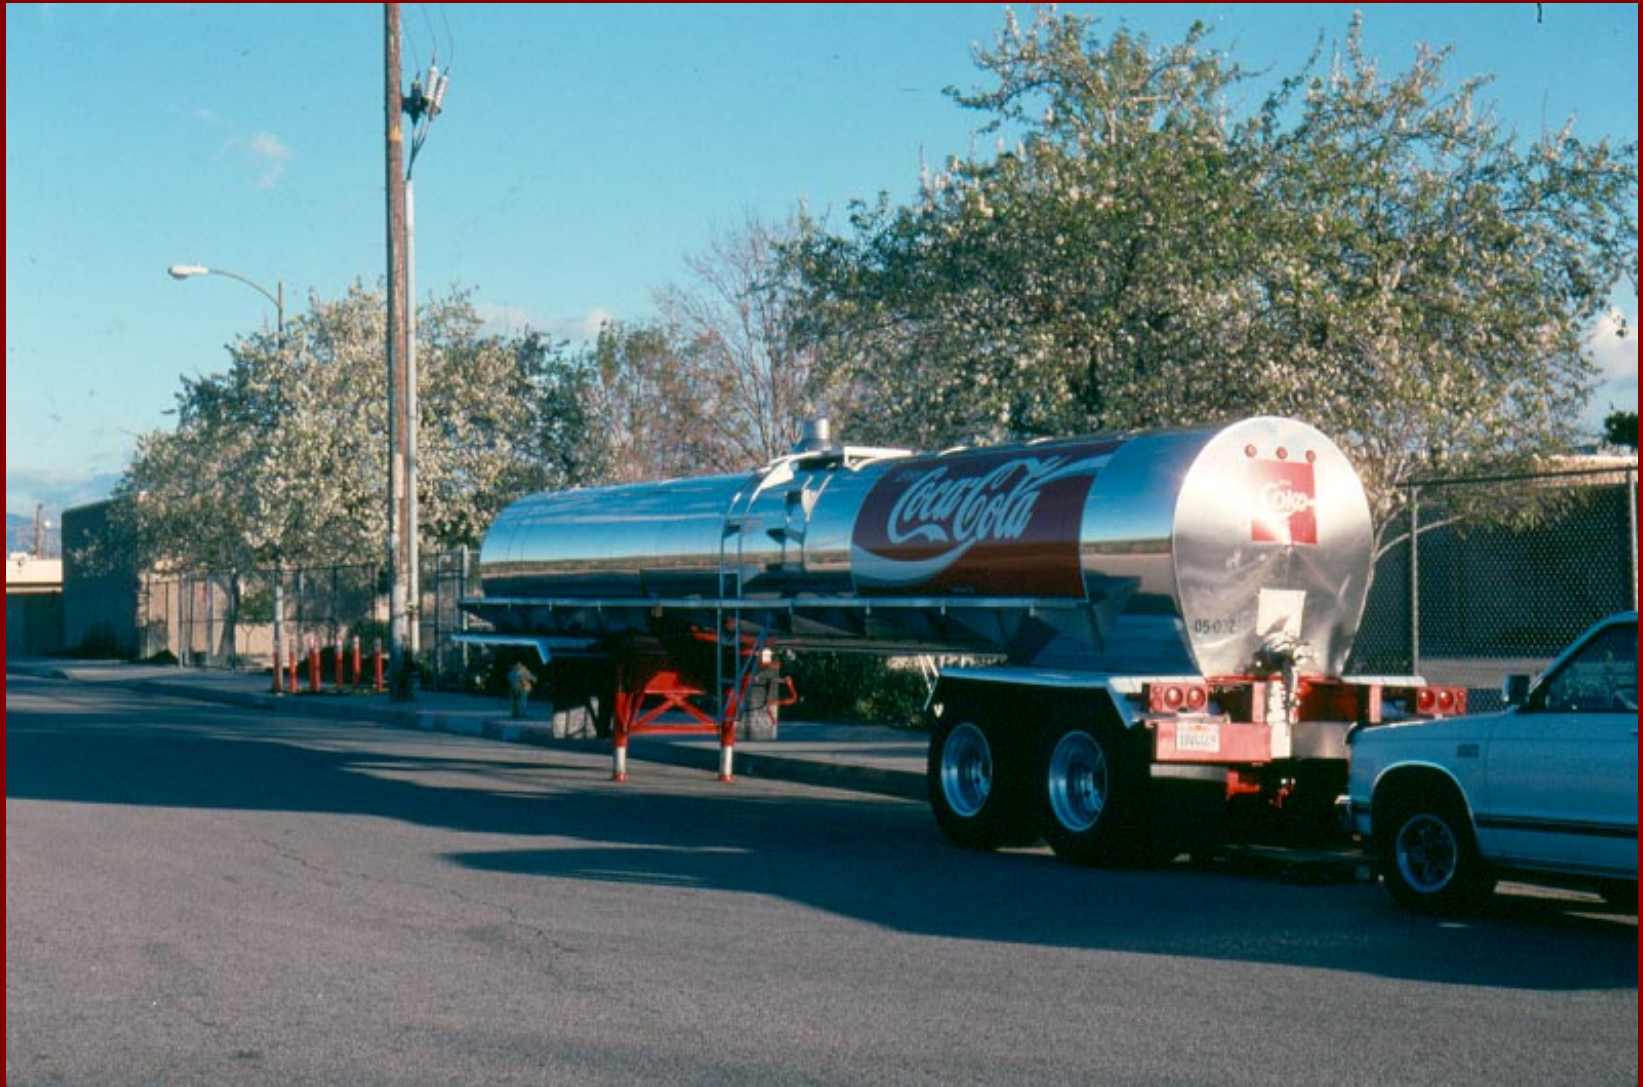
- Public and private tanker trucks
- Bottled water companies
- Fire Engine interdepartmental pumping
- Boil water notice issued for drinking and cooking

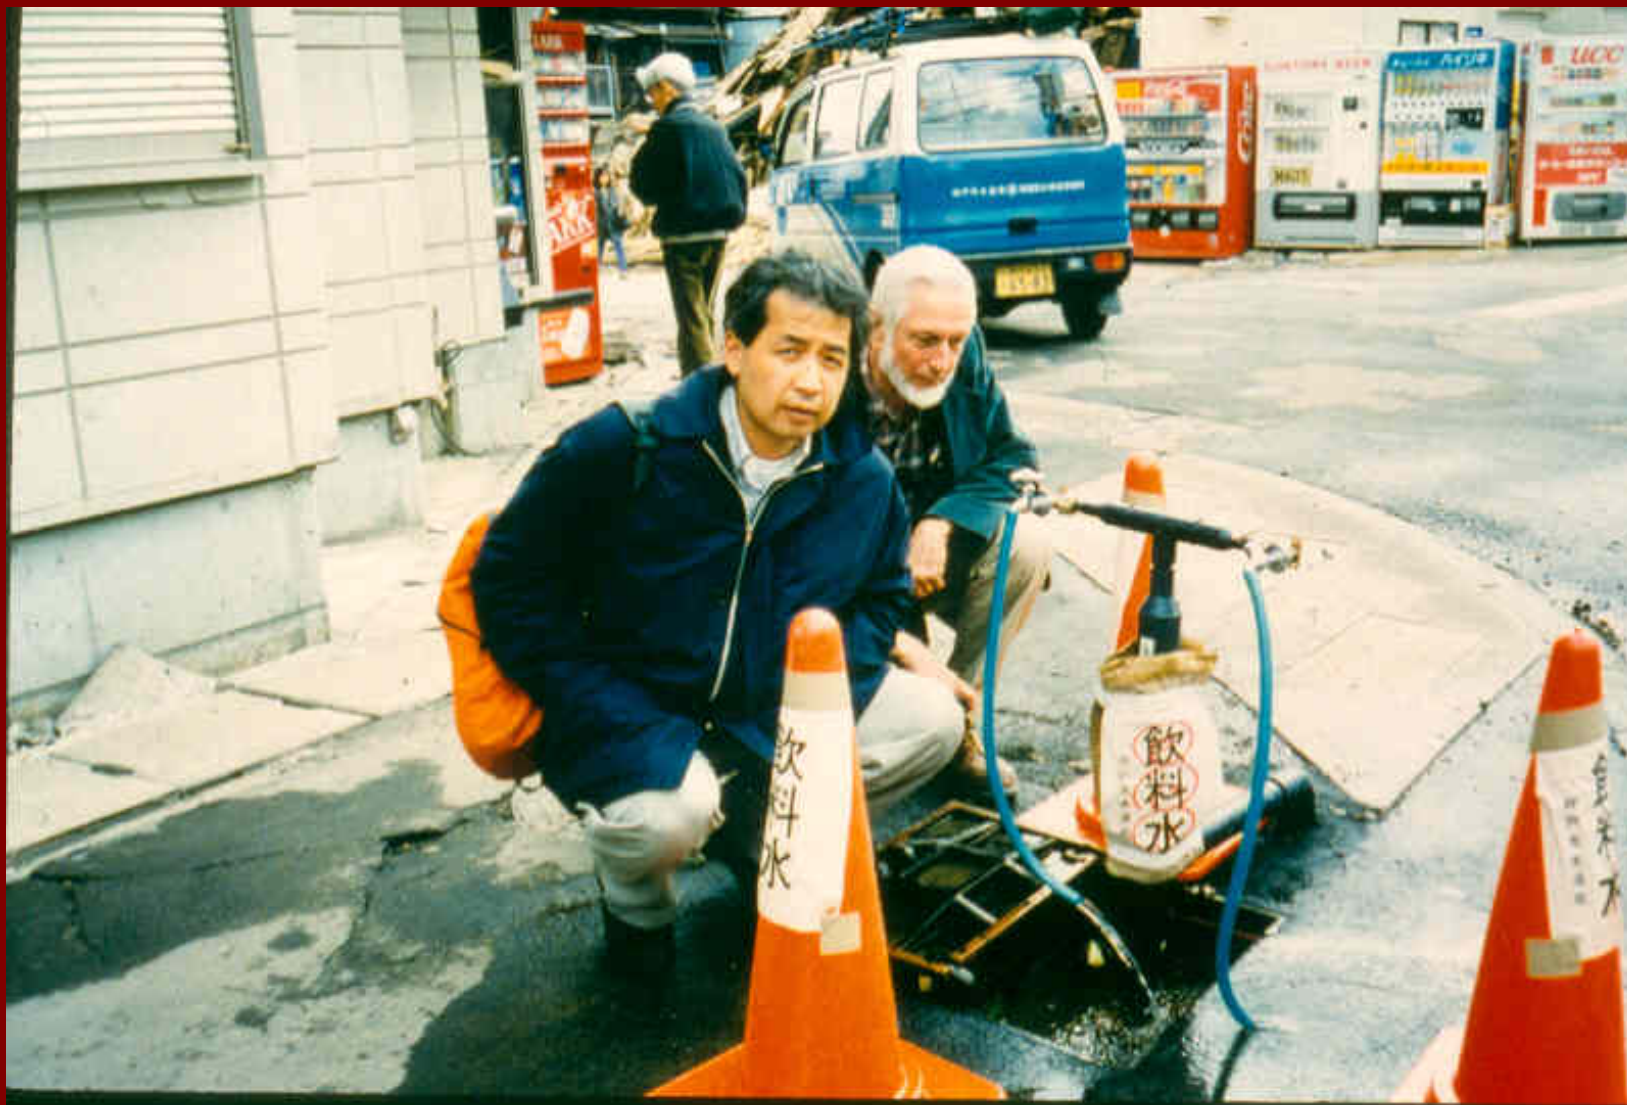
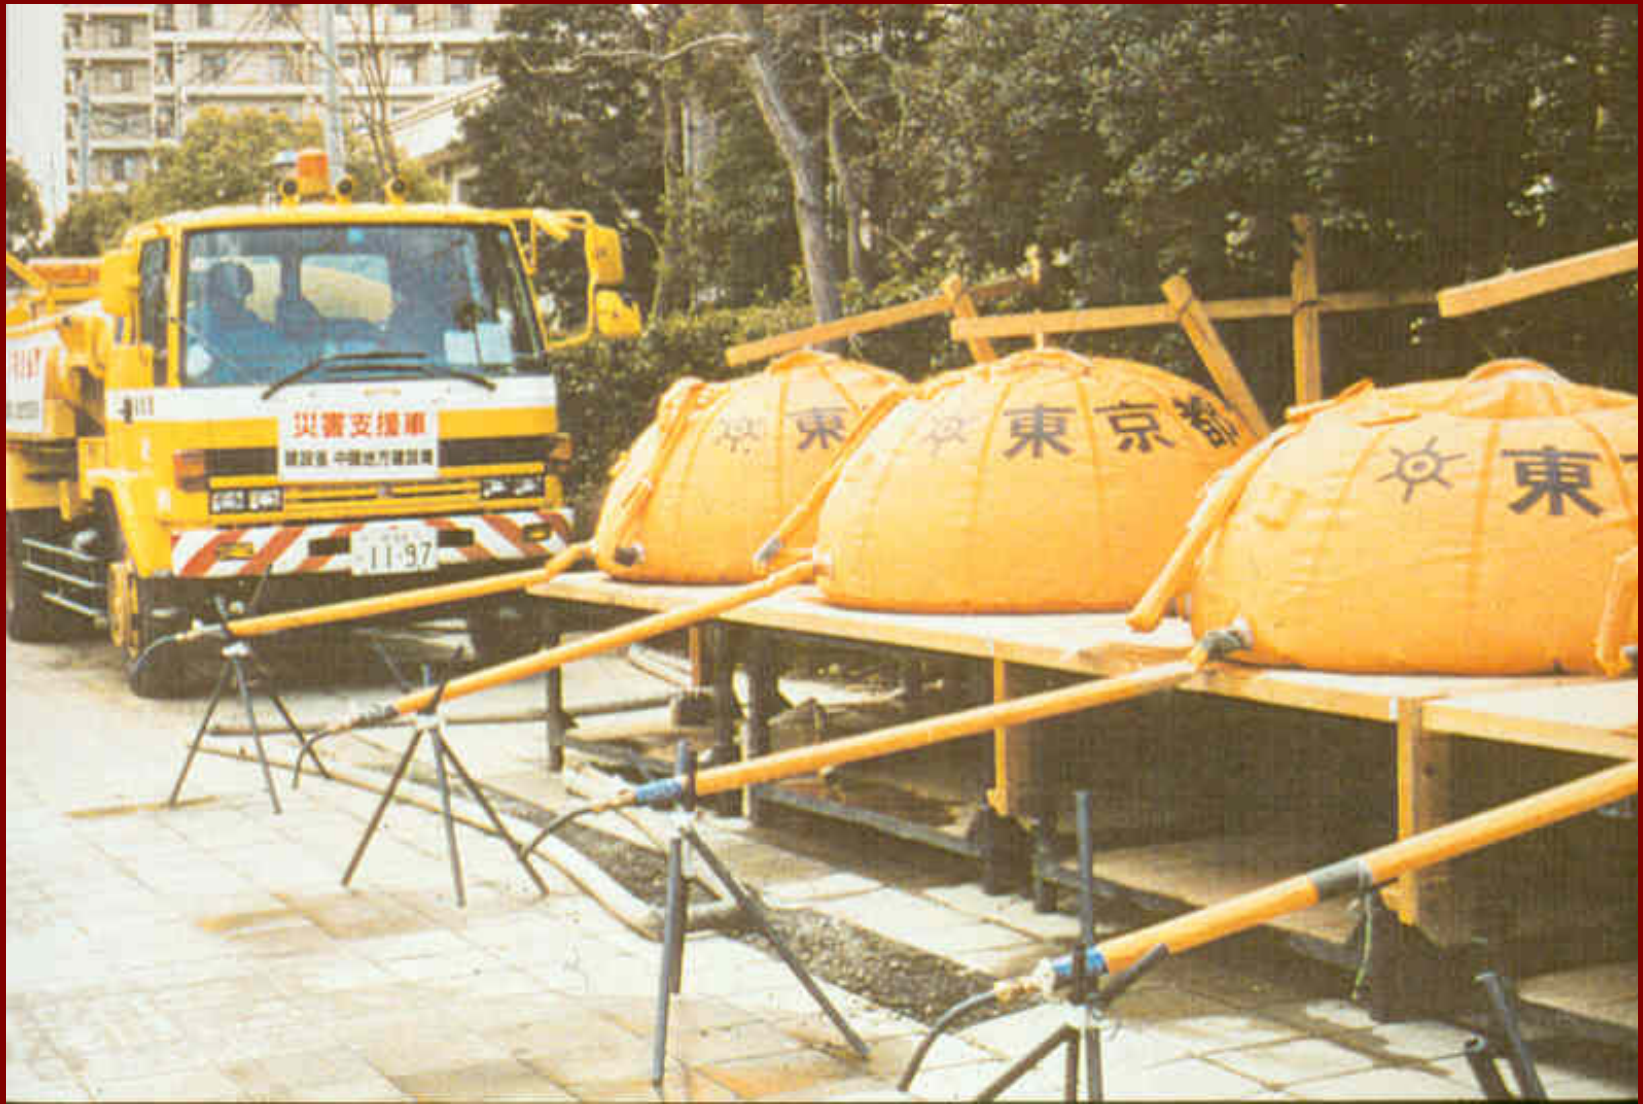
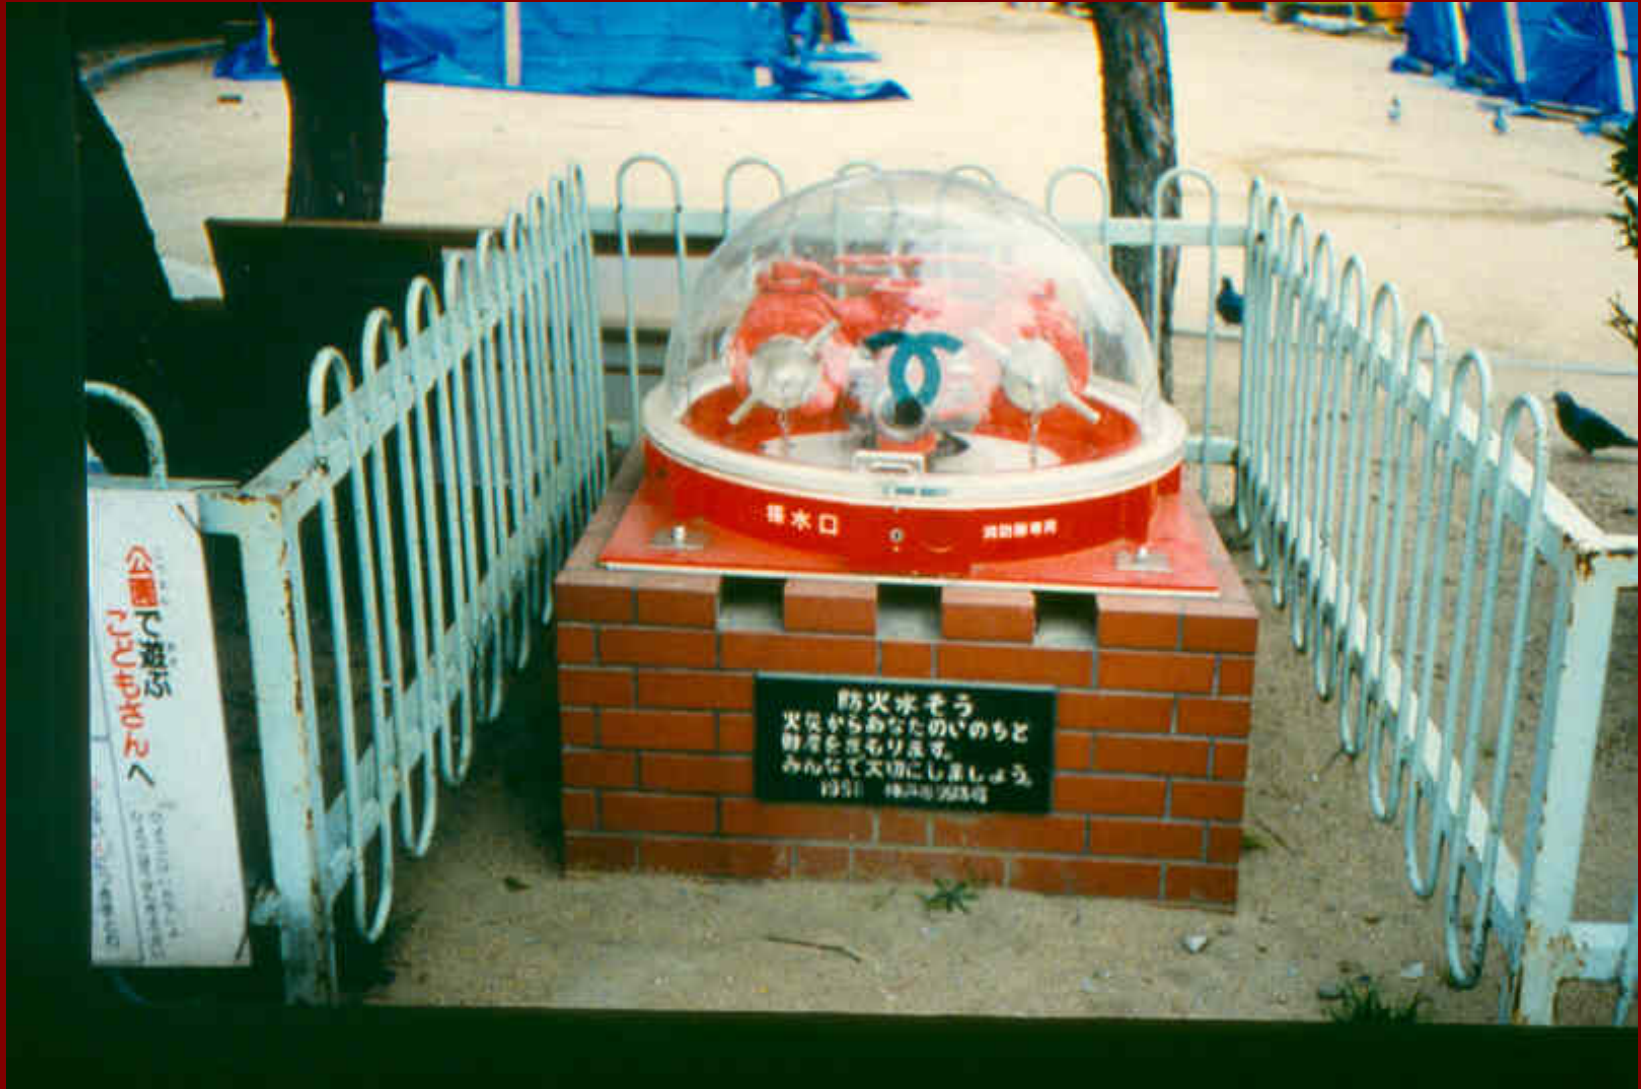
- Dual tanks
- Underground cisterns
- Tank trucks
- Fire hydrant spigots
- Portable tanks
- No boil water notice-concern gas+fire

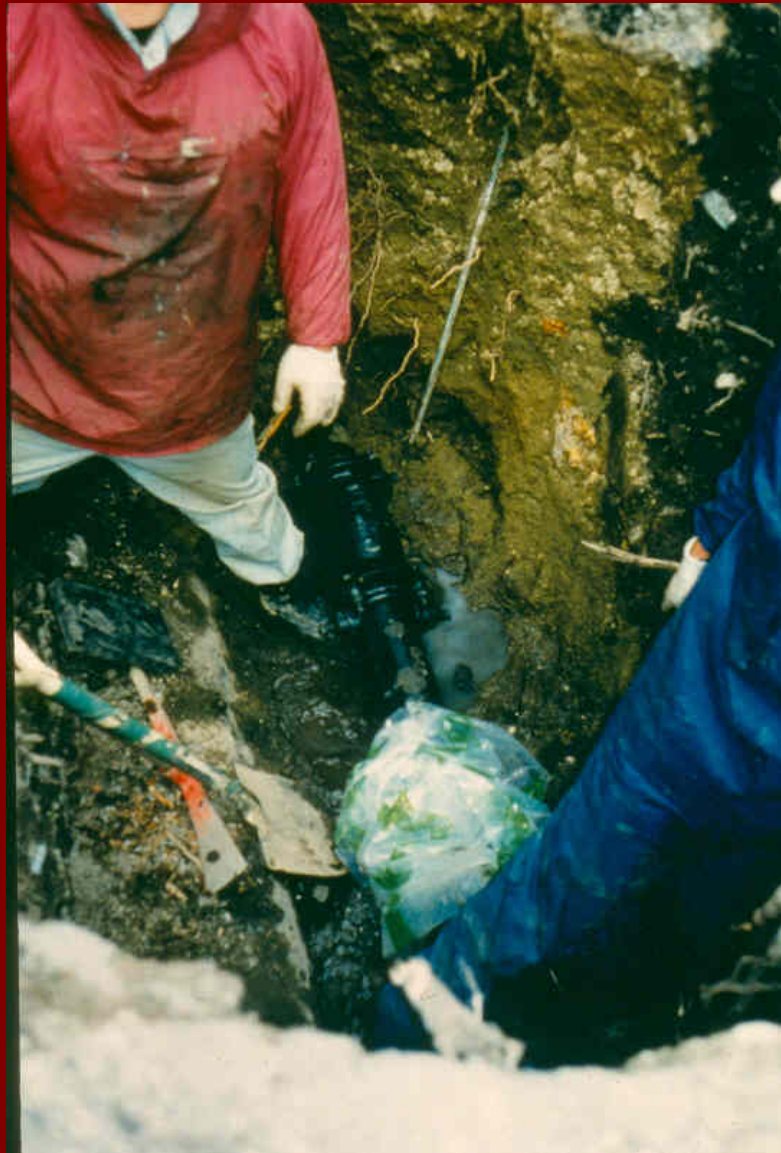
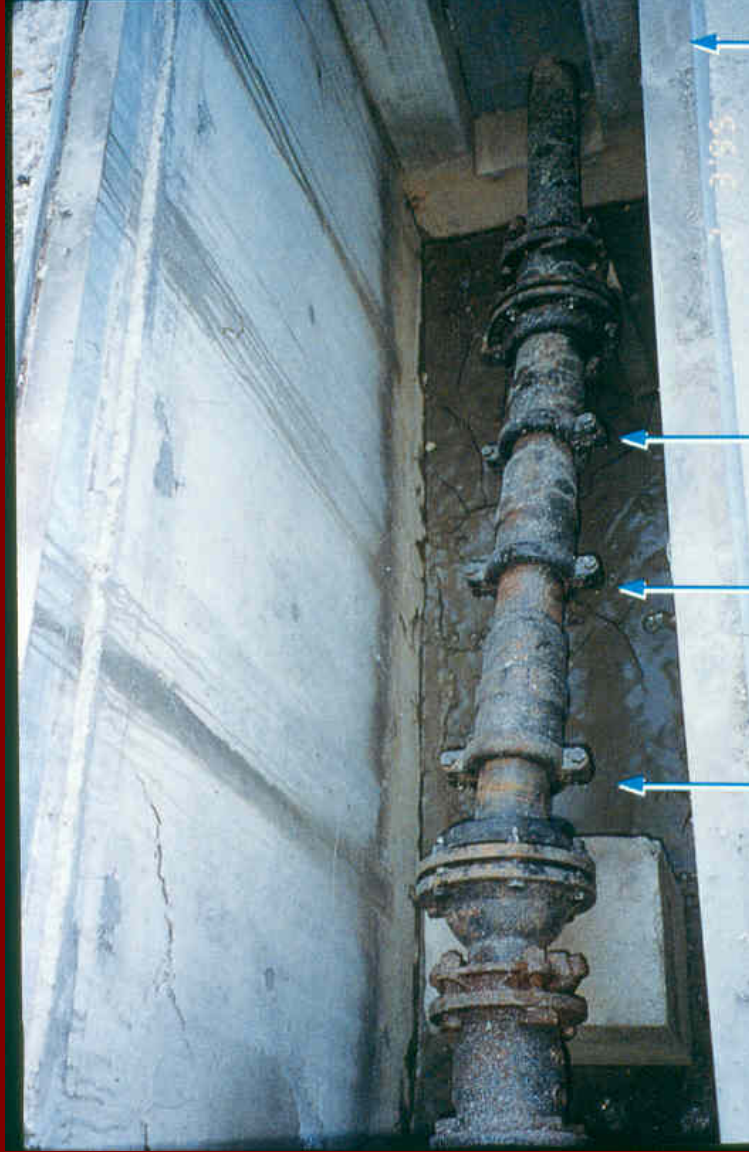
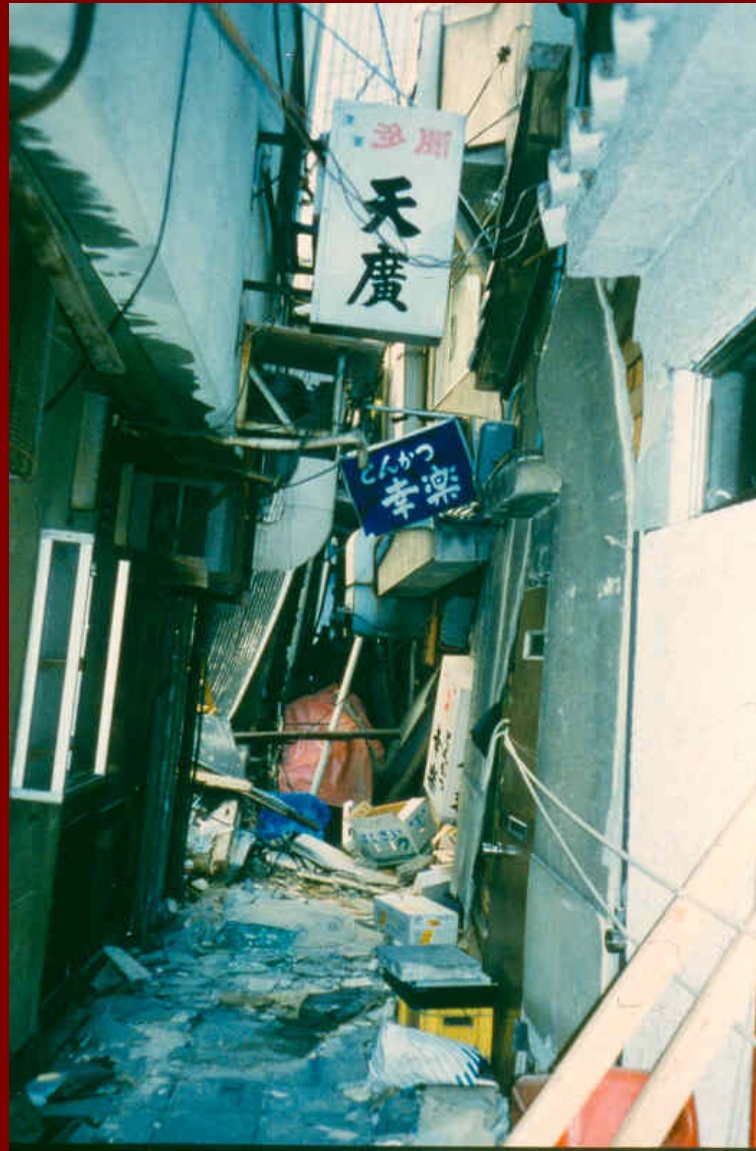
- Five operating districts
- Mutual aid
- Repairs hampered by blocked streets from collapsed buildings
- Access to city limited by damaged highways and railroads
- System water pressure not sufficient to locate leaks
