Tri-Center Field Mission 2002: Taiwan

Diego Lopez Garcia

Department of Civil, Structural & Environmental Engineering, University at Buffalo

Summary

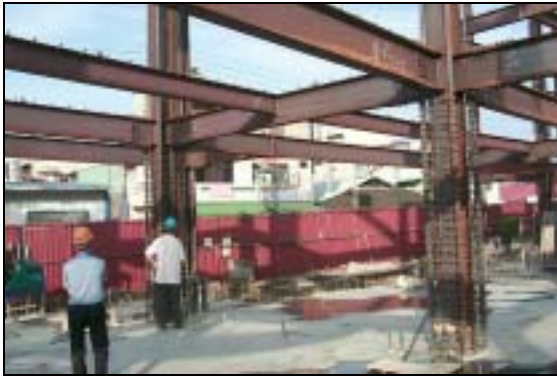
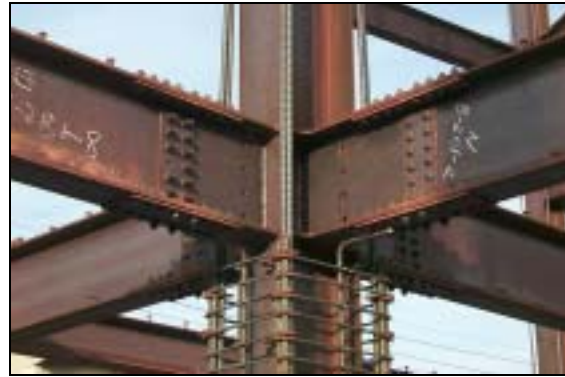
Figure 5. New school building under construction: composite RC-steel frame

School buildings were also severely affected by the Chi-Chi earthquake and many of them collapsed (Figure 4a). An example of retrofitting measures can be seen in Figure 4b, where metallic dampers have been added to an existing steel structure. Figure 5 shows a new school building under construction, where frames are made up of composite RC-steel members.

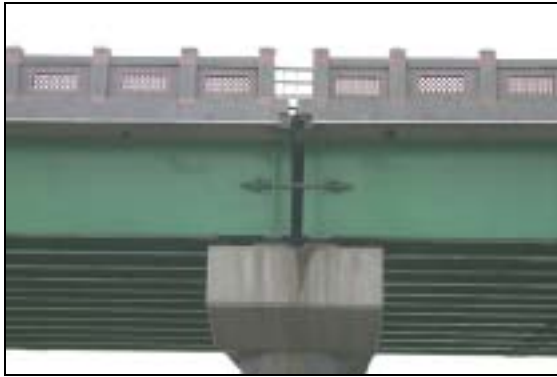
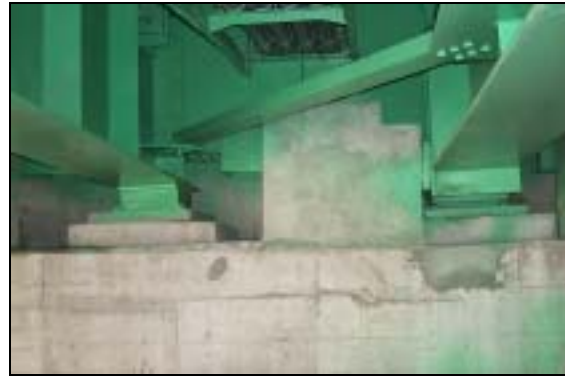
The Chi-Chi earthquake caused many bridge structures to collapse. Many bridges were directly affected by surface rupture and the consequent ground movement. These bridges collapsed due in large part to unseating of one or more simply supported spans (Figure 6a, Figure 7a), which was the typical structural configuration for bridges in service at the time of the earthquake. Other kinds of failures were also observed (Figure 8a). These bridges have been reconstructed, either partially (Figure 6b) or totally (Figure 7b, Figure 8b). An example of partial reconstruction is the Bei-Feng bridge (Figure 6), where some of the original columns were not demolished and were used to support the new bridge. The slope of part of the new bridge (Figure 6b) is a consequence of vertical offset. Most of the completely rebuilt bridges have composite decks supported by continuous steel girders (Figure 7b, Figure 8b), which seems to be the preferred structural configuration for new bridge structures in Taiwan. Joints between continuous segments are located at pier locations (Figure 9a) and the superstructure is supported through elastomeric bearings (Figure 9b). Restrainers against both longitudinal and transverse displacements are usually provided at pier and abutment locations (Figure 9).
