## Issues of Seismic Response and Retrofit for Critical Substation Equipment

Ali Ashrafi

Graduate Student, Department of Civil and Environmental Engineering, New Jersey Institute of Technology

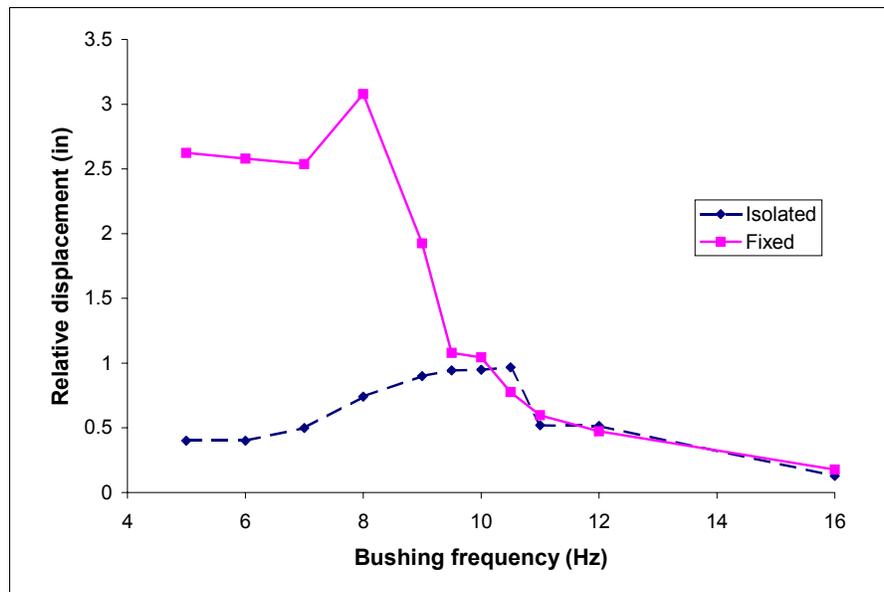
force and response of the transformer are also reduced considerably by use of FPS. Figure 2 shows the bushing response for bushings mounted on a transformer with a horizontal frequency of 8 Hz.

Figure 2. Response of a bushing mounted on a transformer

The response of a wide range of fixed and isolated primary-secondary systems is analyzed. The system characteristics were chosen based on previous studies (Ersoy 2002, Gilani et al., 1999) in such a way to represent the actual transformer and bushing characteristic range. The primary systems are also flexible in the vertical direction to include the effects of vertical excitation in different response parameters as well. The results show the effectiveness of FPS in reducing bushing response for all frequencies. Isolation is effective, even for high system frequencies, and prevents bushing response resonance when its frequency is close to that of the transformer. The base shear

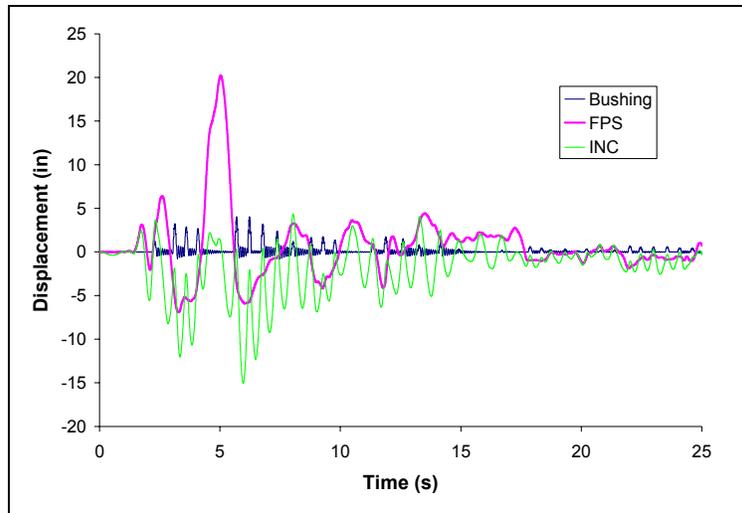
Figure 3. Time history responses in the interaction of transformer-bushing and interconnecting equipment

To study the interaction between transformer-bushing and other interconnecting equipment, a simplified model is used. The cable connection to the interconnecting equipment can be taut or have different amounts of slack. The interaction between transformer-bushing and interconnecting equipment is observed to have an adverse effect on different responses, particularly bushing response. This effect exists independent of the relative value of the FPS frequency to that of the interconnecting equipment. This phenomenon is even observed when these frequencies are equal. The FPS response is the predominant factor determining the behavior of the various interacting components. Figure 3 shows the significant effects on bushing and interconnecting equipment, caused when the FPS slides away from the interconnecting equipment, causing tension loads in the connecting cable. Even the slightest interaction has significant adverse effects. Therefore, interaction of the transformer-bushing with the interconnecting equipment must be prevented at any cost. One way to insure this is to provide a slack equal to the sum of the maximum absolute values of FPS and the interconnecting displacements in the connecting cable. To help choose the appropriate FPS radius and slack amount, numerous analyses were performed for several earthquake records and different soil conditions, FPS radii, and ground accelerations. Graphs are developed showing the FPS displacement and the inertia reduction for different situations and suggestions are made, based on these graphs, on how to choose the proper FPS radius. Figure 4 shows such a graph, providing the average inertia reduction versus ground acceleration for records on soil.

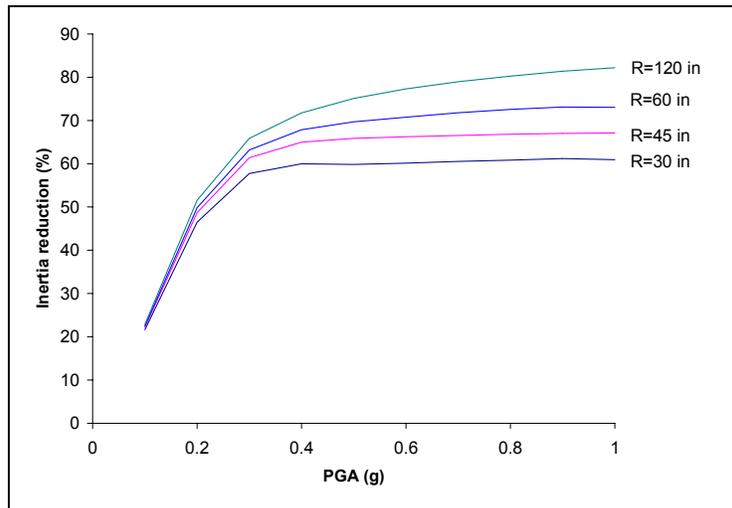
Figure 4. Average inertia reduction versus peak ground acceleration for soil

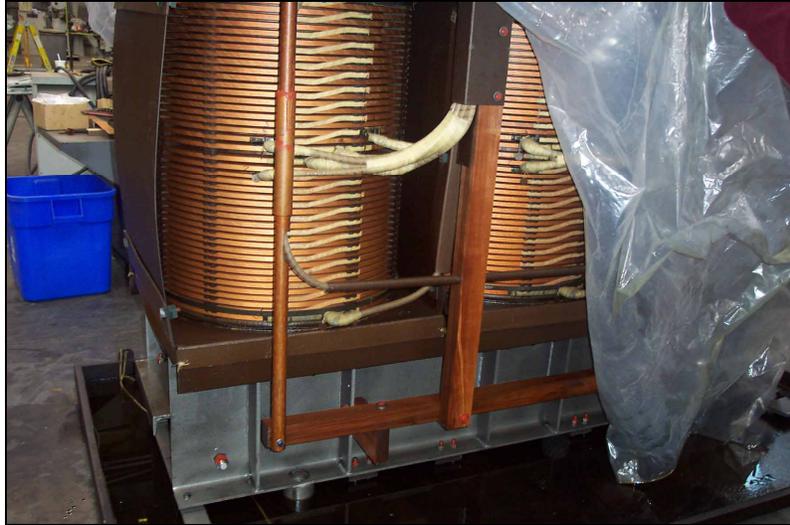
**Figure 5. Internal components of a transformer**

The seismic behavior of internal components of a transformer is studied to ensure that they are not structurally damaged and can continue their electrical function after an earthquake. Four modes of damage and failure are identified for the internal components, of which the sliding of key spacers and loss of close fitting tolerances between limbs and yokes are investigated as the most critical cases. Both of these damage modes can be attributed to loss of prestressing. The tensile forces in windings and core caused by vertical excitation are modest, and are easily offset by the typical prestressing forces. Therefore, it seems that failures of internal components in earthquakes for structural reasons is very unlikely, unless the prestressing is lost before the earthquake occurs. This also suggests that more focus should be put on other reasons to explain the occasional internal damage observed in past earthquakes in the form of slipping of key spacers. This subject is still under study and further analyses are being conducted. Figure 5 shows the internal components of a transformer.
